## Arkansas Governor's Mansion Commission

SUBJ: Annual Mansion Report

DATE: November 1, 2016

### TRANSMITTAL AND CONDITION DEFINITIONS

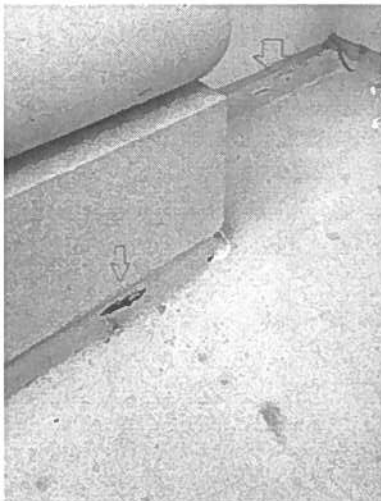
- d. The collected roof drainage is discharged through openings in the side walls. There is some splash related damage to the right of the west upper level entry. Caulking material used at the base of the exterior walls has been damaged allowing water to enter.

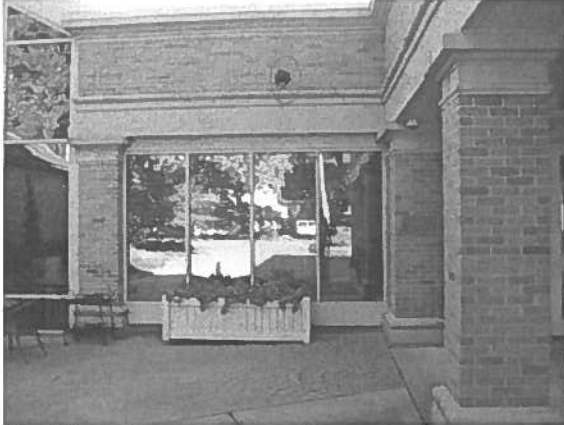
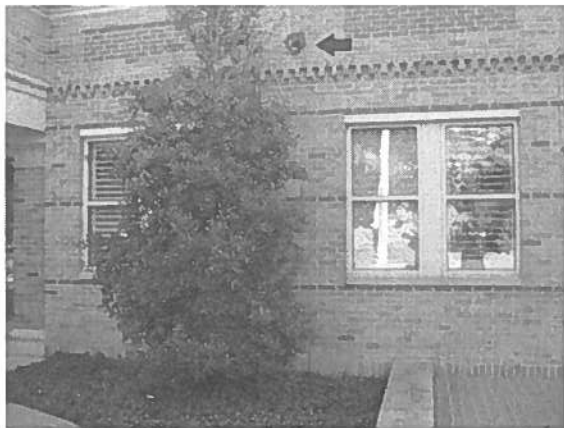
The opening to the right of the same entry discharges into the trapped bedding area.

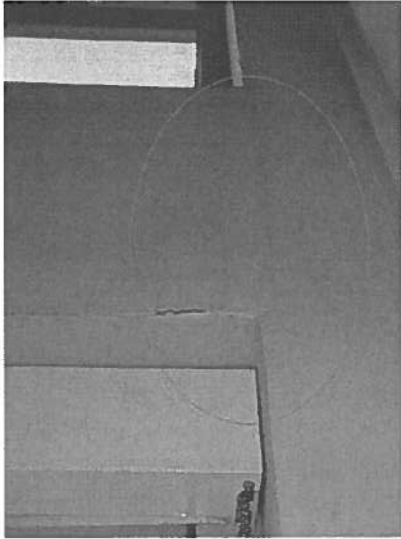
- a. There is evidence of moisture entry in the last window unit on the south west. The wall material is water damaged as a result.

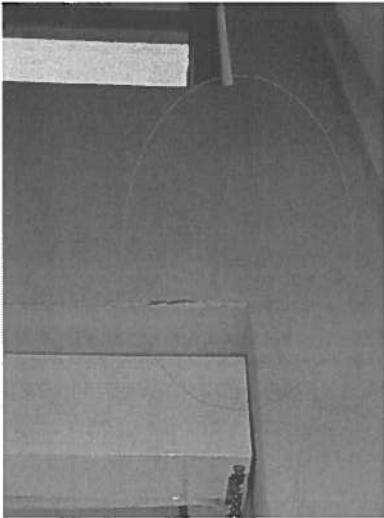
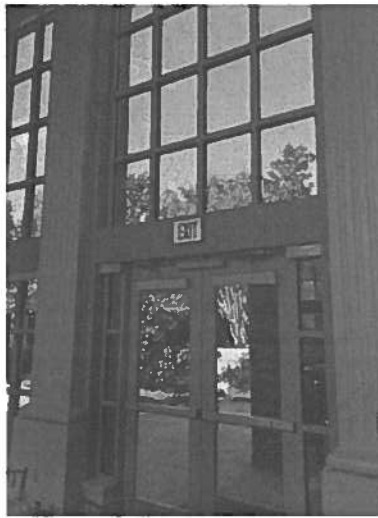
- a. The wall covering material has been water damaged below the top row of windows in the south west rear. The material is water streaked and cracked.
- l. Seam cracking in the sheet rock is noted at the headers between the window units. Repairs have been attempted but poorly executed.
- m. There is evidence of paint repair along the West side between the original structure and the Grand Hall. This may be related to the roof drainage / discharge left of the west entry. Having the history of water related issued in this area would be helpful.  
Comment: Shrinkage cracking is indicated in the crown moldings and columns. This is a common occurrence in most structures. This shrinkage halts after the structure has been several years in a conditioned environment.

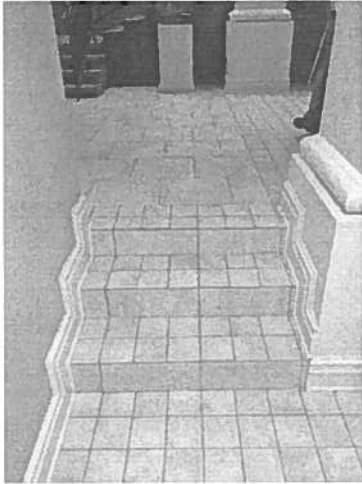
- c. Railings and banisters do not provide child restraints at the ramp area on the east entry to the Grand Hall.
- m. There is no hand (safety rail) rail at the steps down from the foyer to the Grand Hall.

(No hand rail down from the foyer.)

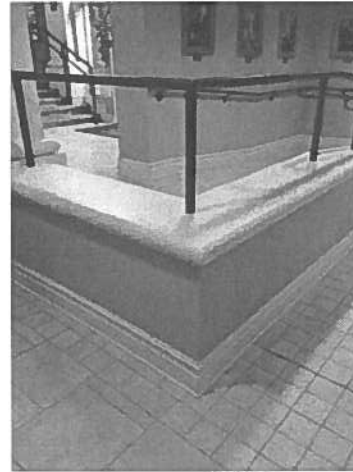
(Inadequate child restraints at the ramp.)

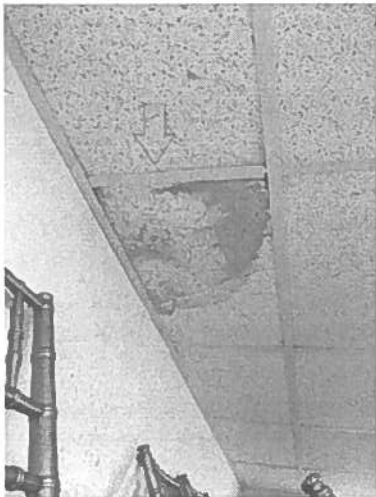
- a. Staining is noted in the electrical closet on the west side. This area is below the west entry. Note the comments regarding roof discharge management.
  - s. Staining is noted in the chair storage area. This is below the flashing repair noted earlier. Active leakage is not indicated in this area.
  - c. Condensation damage to the ceiling area around the HVAC register in the ceiling on the east side of the stage (grand piano)
- [This does not address cosmetic conditions nor non structural damage.]

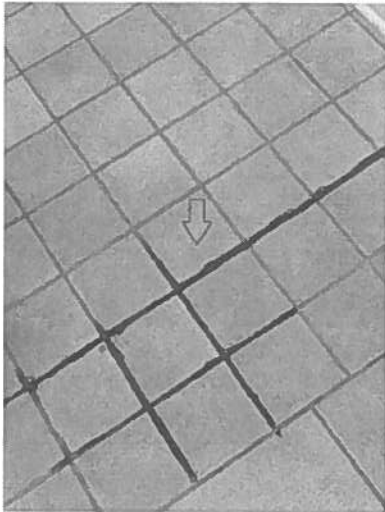
- a. The grout repair does not match properly at the east side entry to the ramp and the base of the ramp.

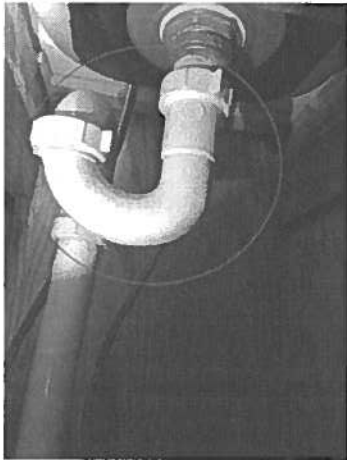
- e. The trap design "S" is not approved. This design syphons the water in the trap and allows sewer gas to enter the structure. The "S" trap was viewed beneath the sinks. The "P" trap design is the approved method.
- f. The sewer vent system was not located for this area. Possible the application of auto vents as a solution.

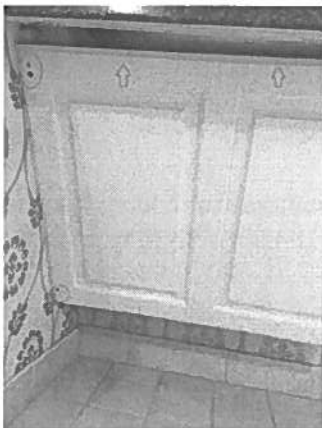
- m. The stopper mechanism is not operating properly at the sink.  
Comment: The plumbing is difficult to inspect and service beneath the sink because of the screwed on front. Approaching failures in the plumbing may not be recognized before the failure occurs.

(Cabinet facade screwed into place. Note the lack of visibility and access to plumbing.)

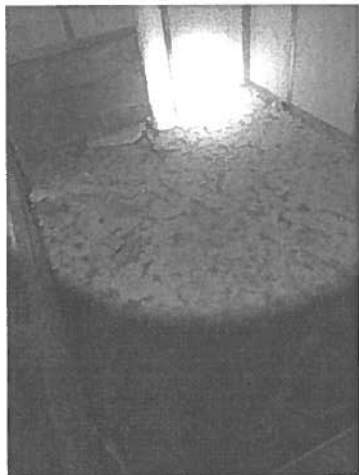
- h. Return duct system is dirty.

Comment: Appears a significant loss of return air could occur where the Grand Hall meets the foyer if the doors are closed.

(Dirty return at the grand hall foyer)

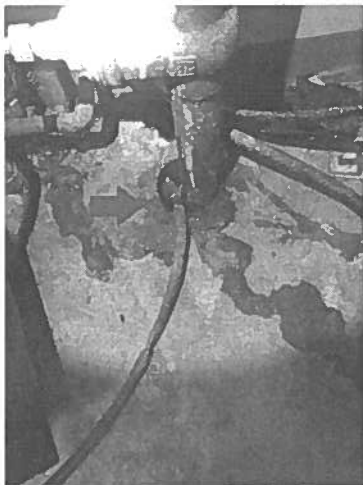
- a. Gutters are leaking at the seams. This leakage tracks down the sides of the structure.
- c. The floor drain in the water heater closet off the office is blocked allowing water to drain onto the floor. Beyond the fact it is draining on the floor, the over all humidity level is elevated in the building causing molds and mildew to develop. This appears chronic and a contributing factor to the over all problem.

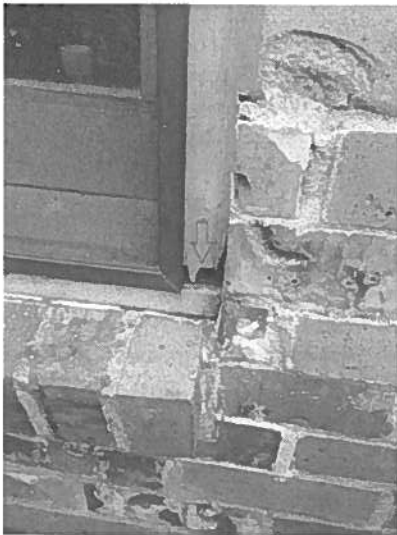
- m. Deteriorated window frame or sash along the right exterior. These windows do not have over hang protection. Water cascading down the exterior walls effects these windows.

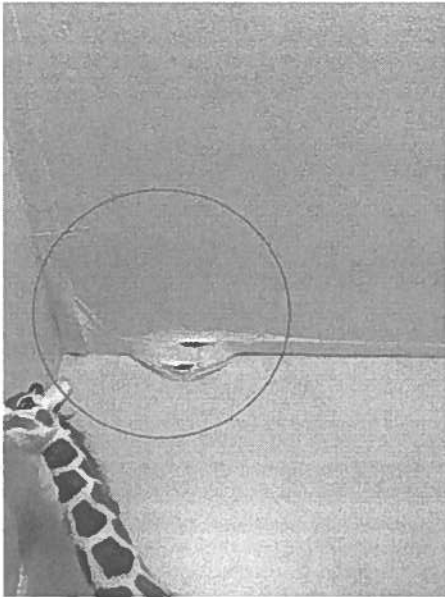
- a. The sheet rock material is water damaged along the rear wall of the office closets. This area is below the HVAC system in the attic above. This does not appear to be a currently active condition. See #115

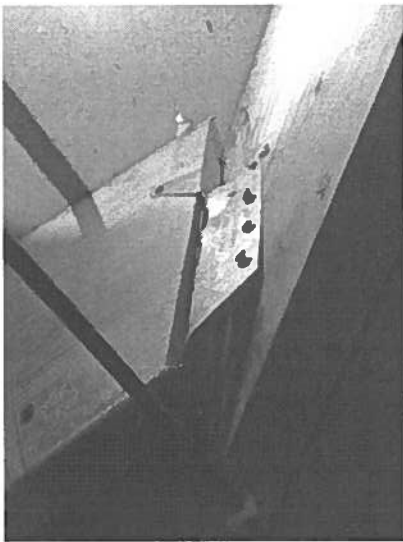
The Carriage House roof structure presents as a poorly thought out, poorly supervised and executed project, using materials not designed for the application. This building will not perform well under wind, snow or ice loading. Recommend a structural engineer review this the building to determine retro fitting that can improve the performance and safety.

The roof system is poorly designed and executed. Failure of the structure is possible under some wind or load conditions. A structural engineer should evaluate these conditions and provide a retrofit solution for the problems.

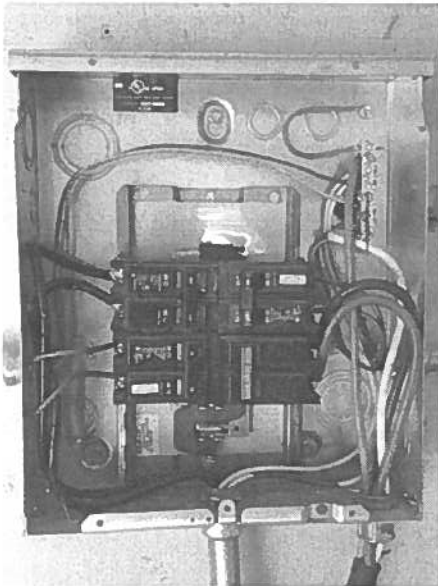
- c. Neutral and ground conductors are mixed on the same bar. Under some conditions this combination can cause an energized ground in the system.
- f. The dryer is wired directly to the breaker. A properly installed receptacle is recommended.
- g. The dryer circuit conductor is not protected by conduit.
- h. The neutral bar is bonded to the panel.

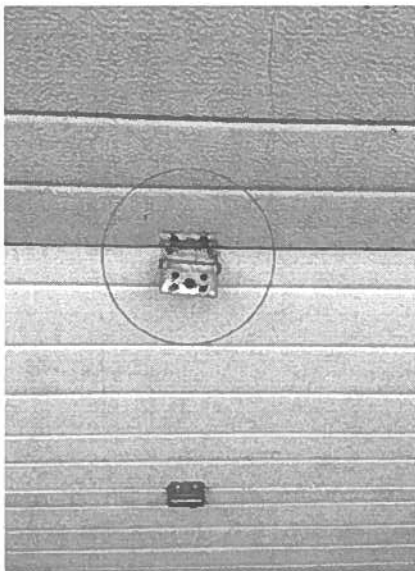
- a. Door hinges are loose. Door failure can result as this condition worsens.

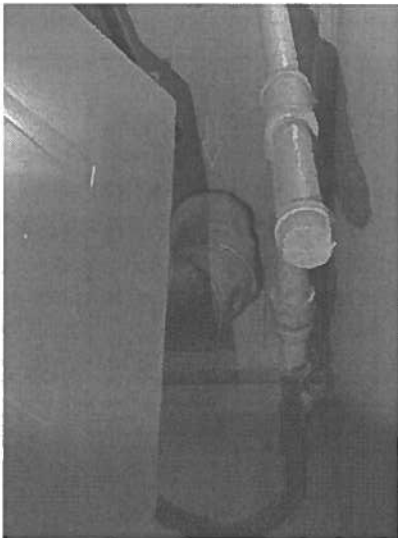
- b. The exhaust vent material is too close to combustible materials. The vent is required to be no closer than 1 inch from a combustible material. This condition was observed at the ceiling penetrations.

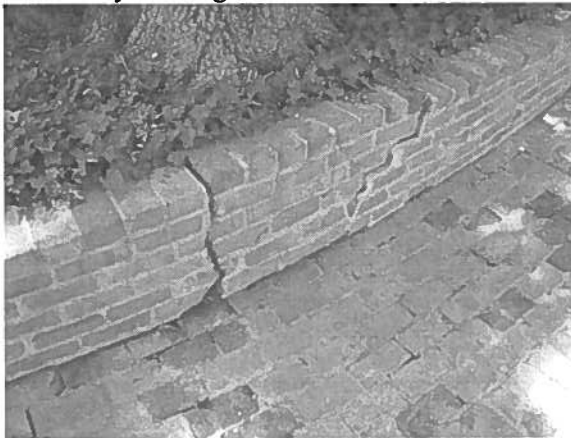
The brick retaining wall is broken at the front right. This appears to be directly related to the growth of the tree near the wall. The solution may prove to be complicated.

- o. The retaining wall is broken at the front right walk. The damage results from the pressure exerted by the large tree in the area.

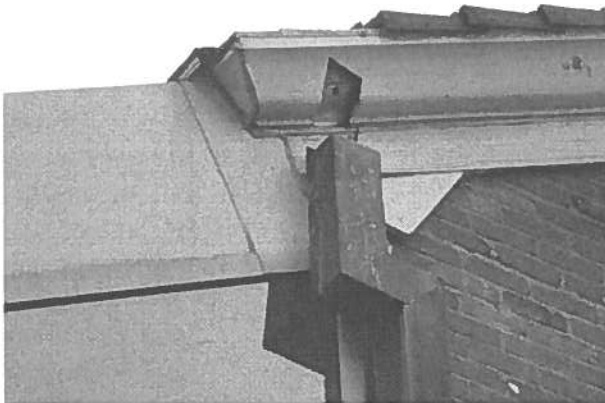
- p. Unused down spouts remain attached to the rear corners of the mansion at the juncture of the glass roofing system. This area is cluttered and the trim areas will require considerable reworking if the down spouts are removed.

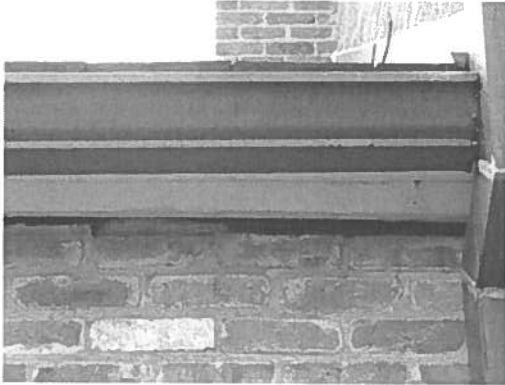
There is an open space between the top of the brick and the trim (frieze) at the rear of the Mansion kitchen. The frieze normally over laps the brick finishing the juncture and preventing animal access. The cause of this open space was not determined during this inspection.

- a. The rear wall of the kitchen (wall facing the west entry to the Grand Hall) is open at the top. The brick does not extend behind the trim (freeze). This does not appear as settlement but possibly an alteration of the trim or roof line. The open area allows animal access into the wall and attic space.

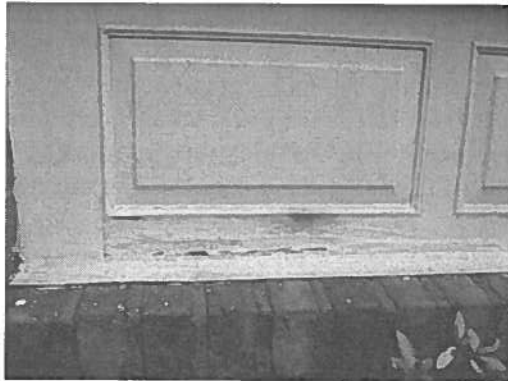
- i. Painted surfaces are in poor condition. Caulking, paint or stain are the protective coatings for these materials. The windows are displaying flaking and cracking in the paint.
- l. The in fill areas below the windows indicate decay at the study front and left side.

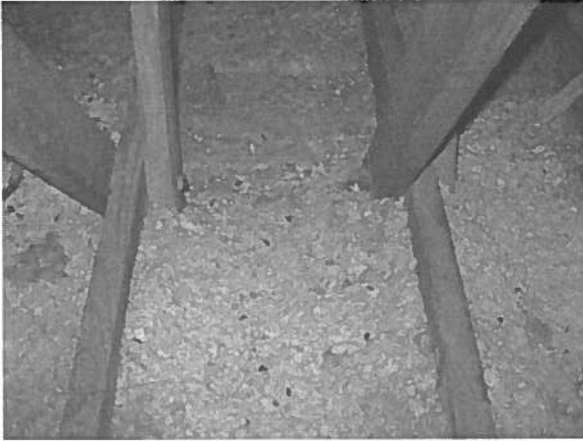
- i. Animals have been active in the attics. This activity has damaged the insulation by compressing the material and by their waste material.

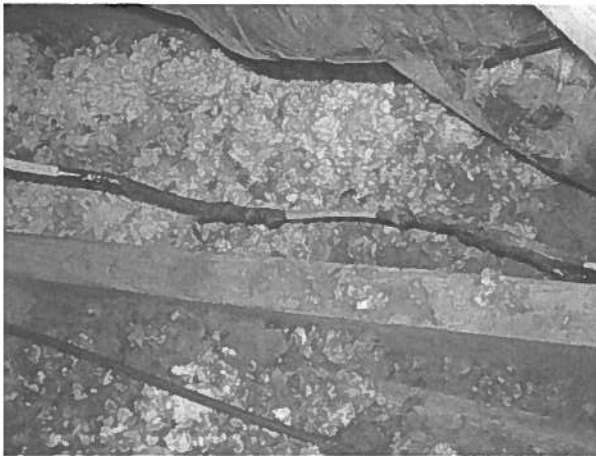
- k. Wiring is on the ground in the crawl space beneath the kitchen. There is a danger of both damaging the conductors and electrical shock.
- u. There are junction boxes that do not have secured covers in the crawl space and basement beneath the kitchen
- p. Rodents have damaged the electrical system in the attic. This damage was observed in the attic above the Governors office. The damage should be investigated further by a licensed electrical contractor.

Comment: The damaged electrical conductors have been taped over since our last visit.  
[There are areas of the wiring system that have not been observed.]

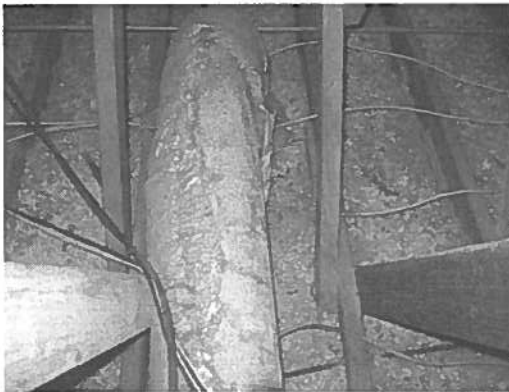
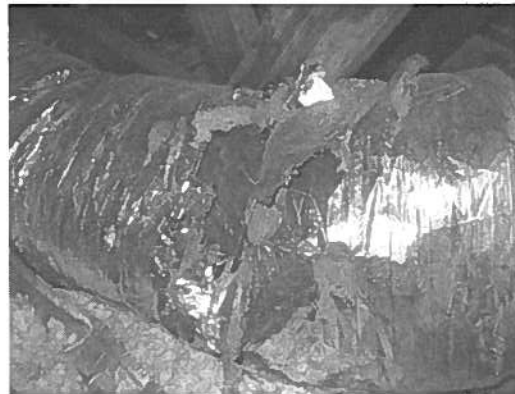
- a. Insulating wrap is damaged in multiple locations.

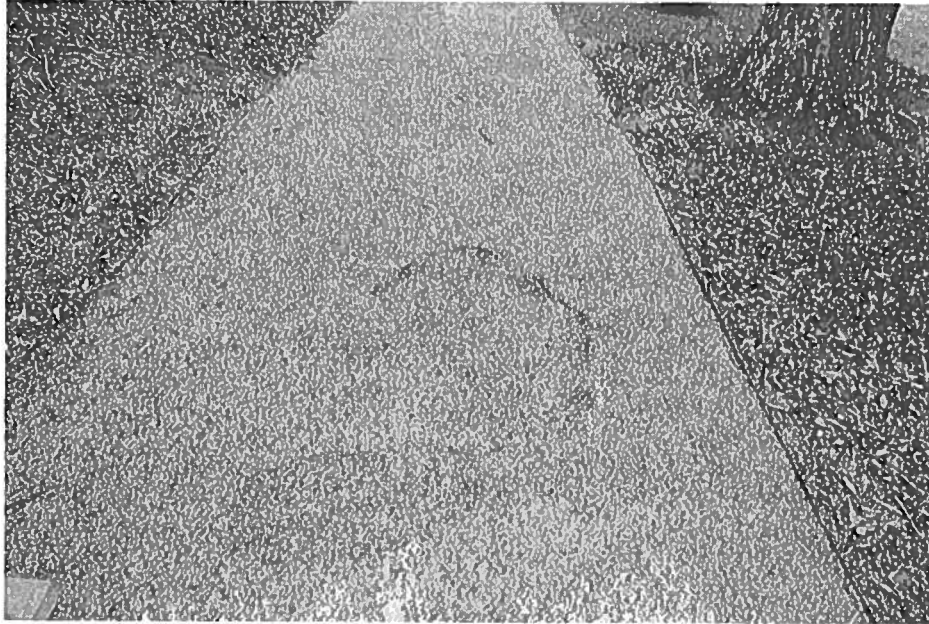
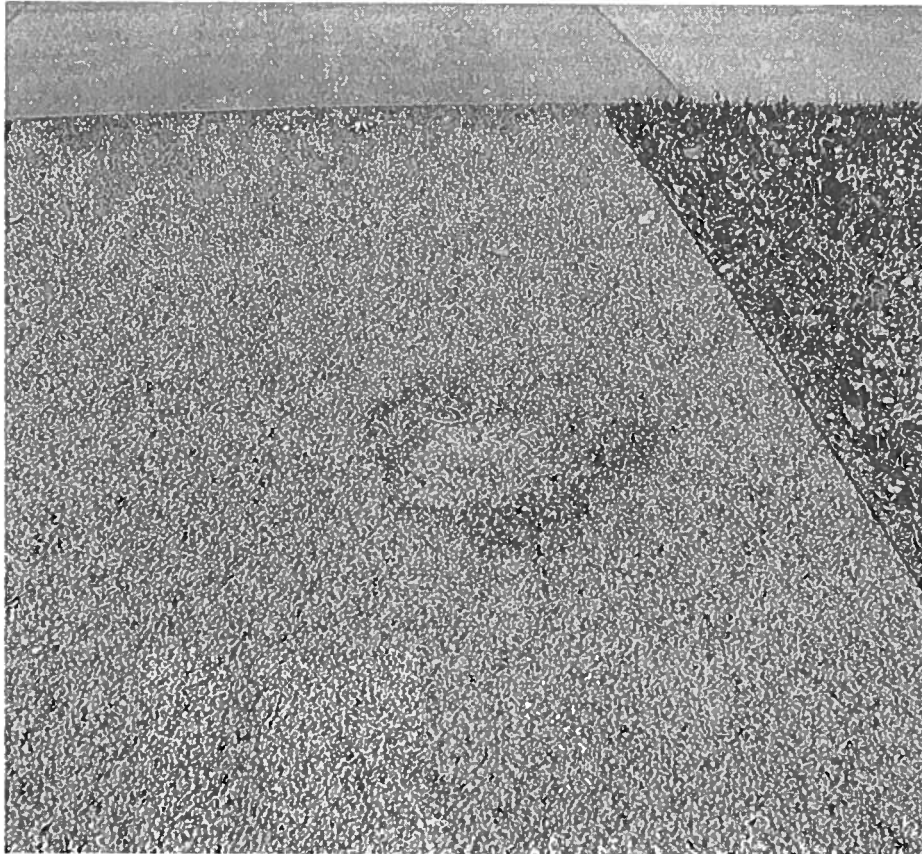
Arkansas Governor's Mansion Preservation Improvements  
Photograph #1

Imperfections developing in Mansion Garden Chat Paths

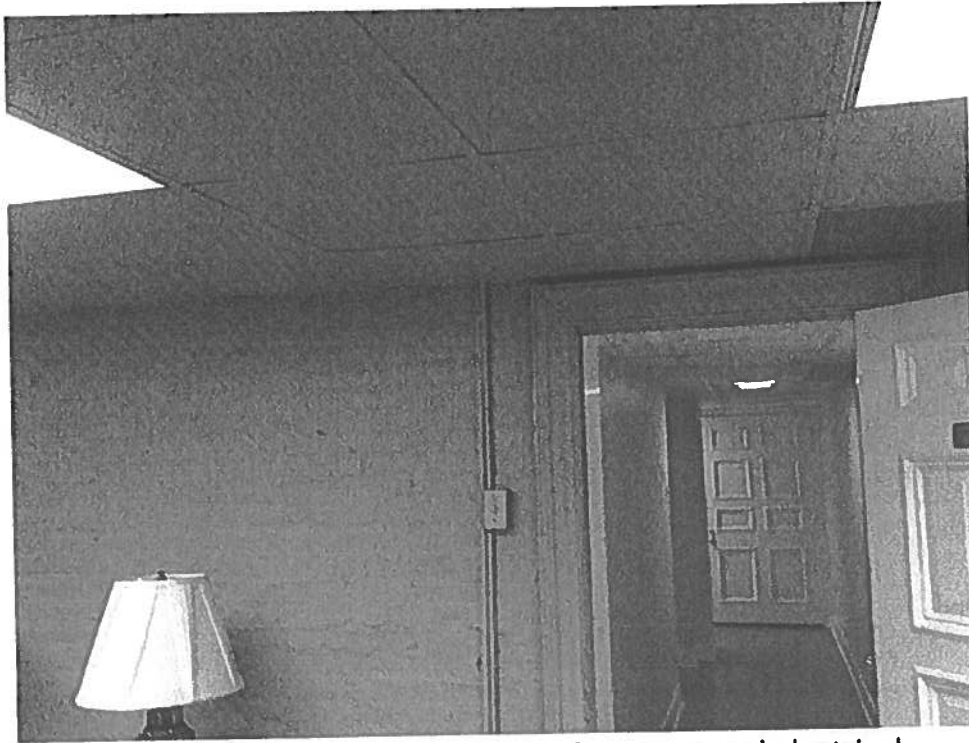
Arkansas Governor's Mansion Preservation Improvements  
Photograph #6

Family Room – low drop-in ceiling and surface mounted electrical conduit

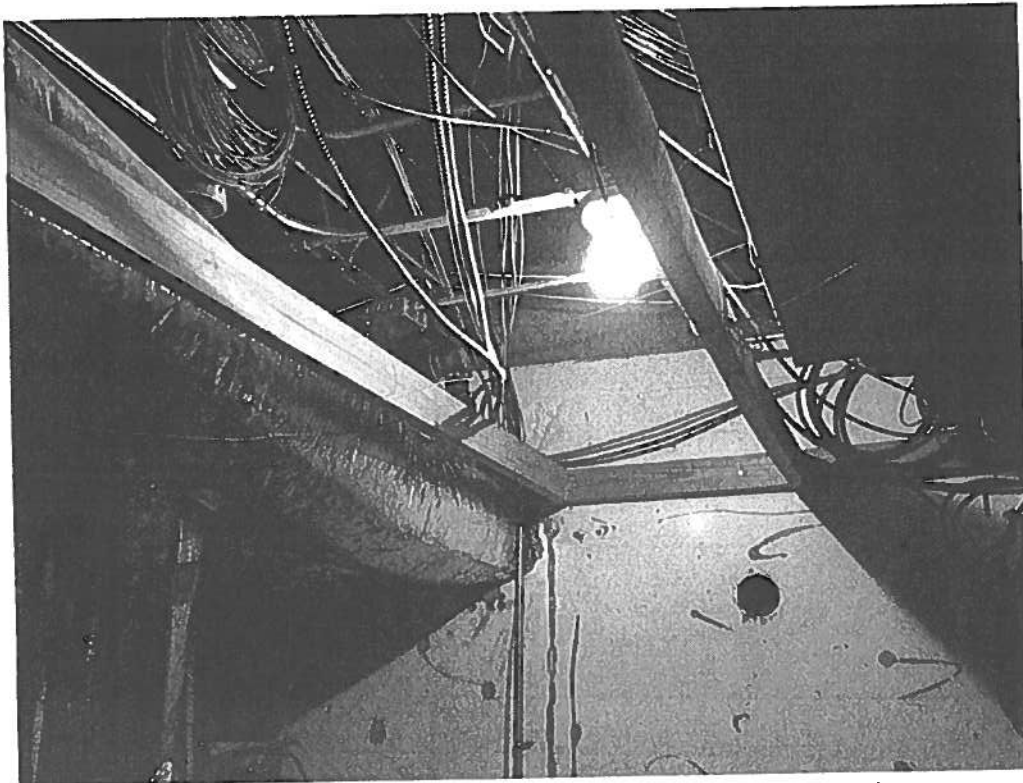
Family Room – example of abandoned wiring above ceiling to be removed.

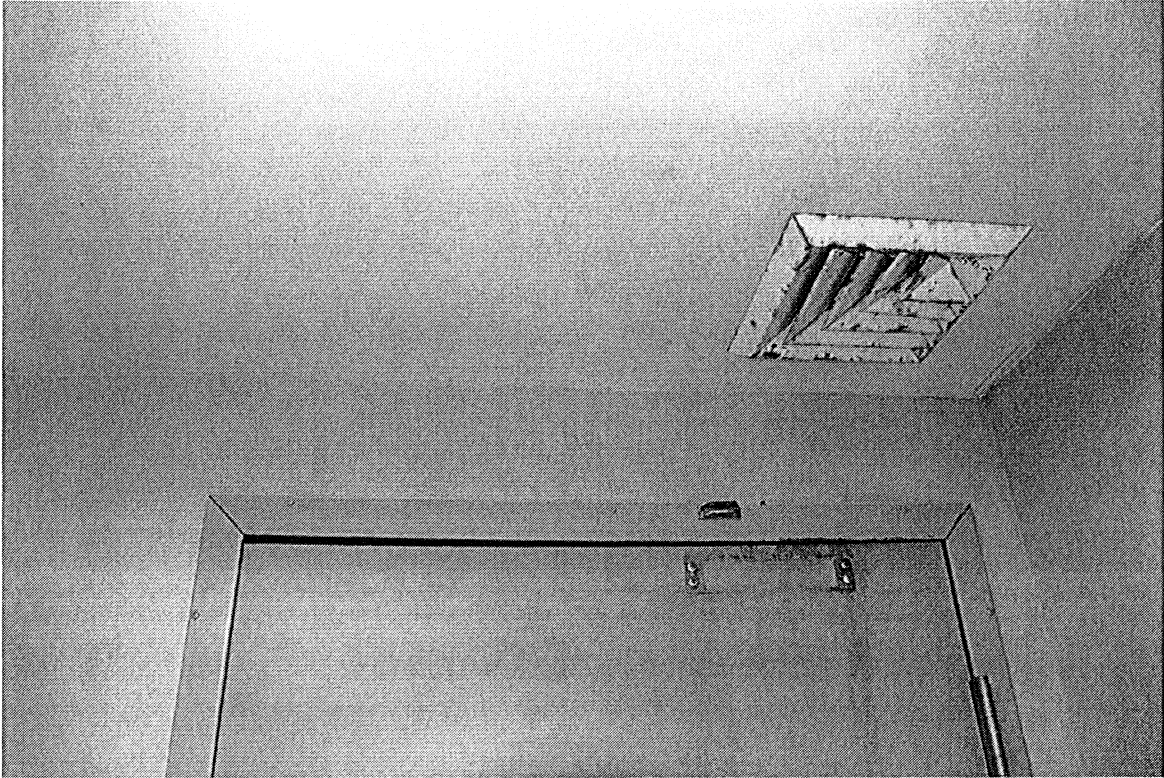
Arkansas Governor's Mansion Preservation Improvements  
Photograph #8

Evidence of moisture issues in Governor's Office

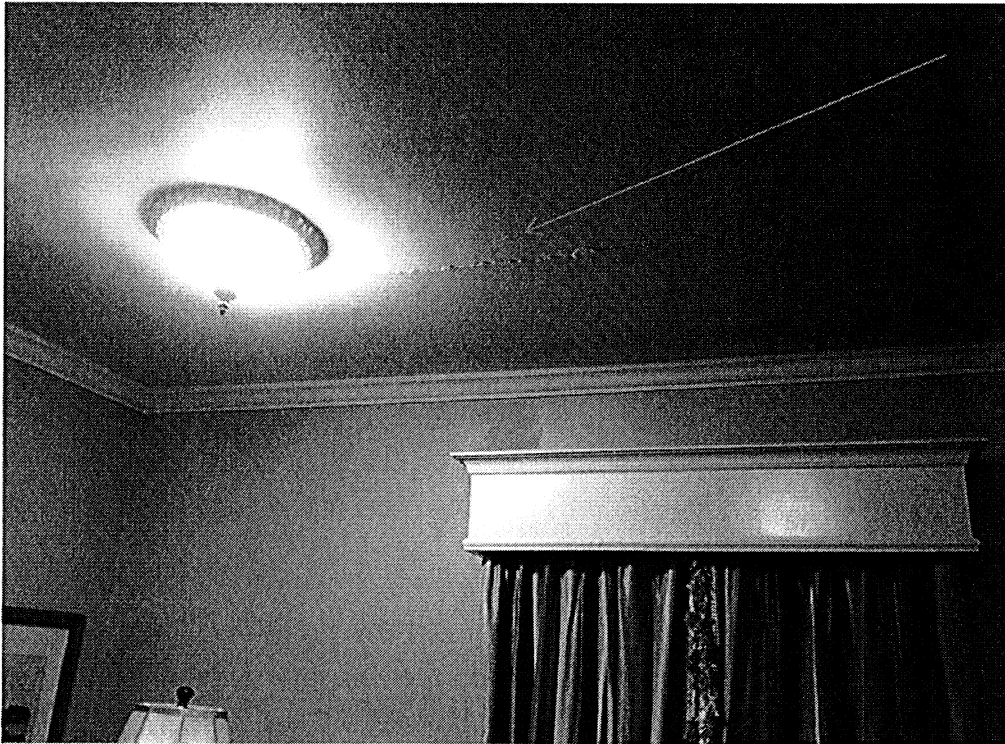
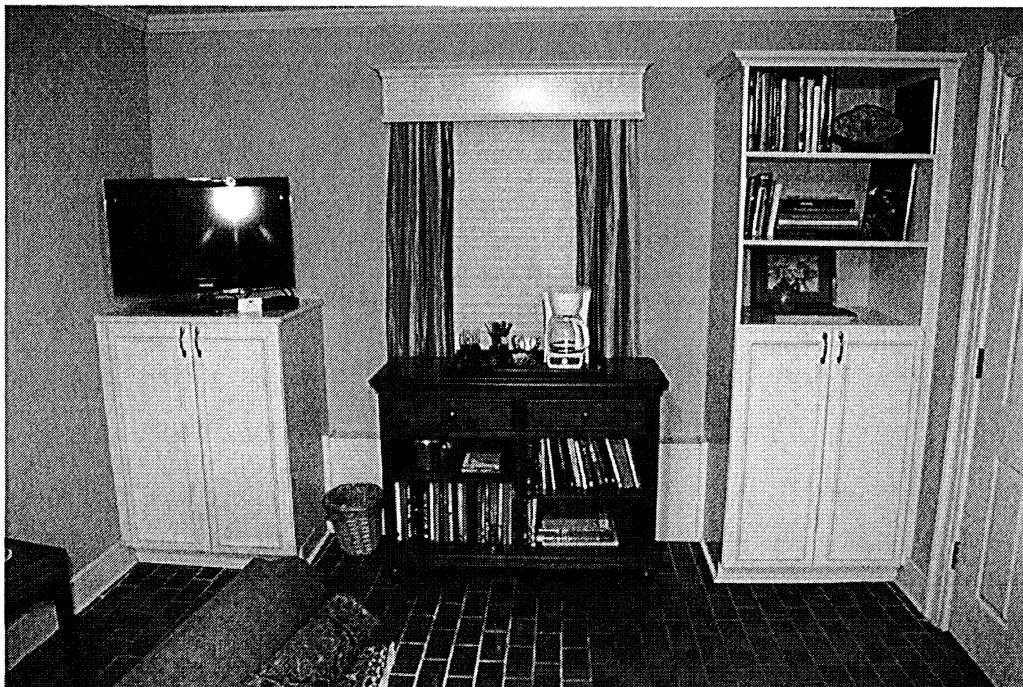
Arkansas Governor's Mansion Preservation Improvements  
Photograph #9

Guest House: Above – showing crack in ceiling  
Below – built-ins to be removed & replaced

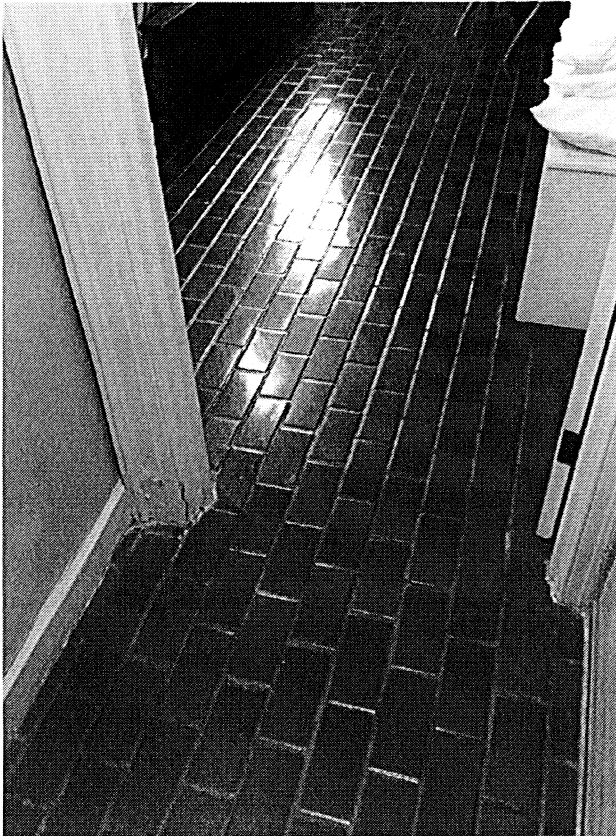
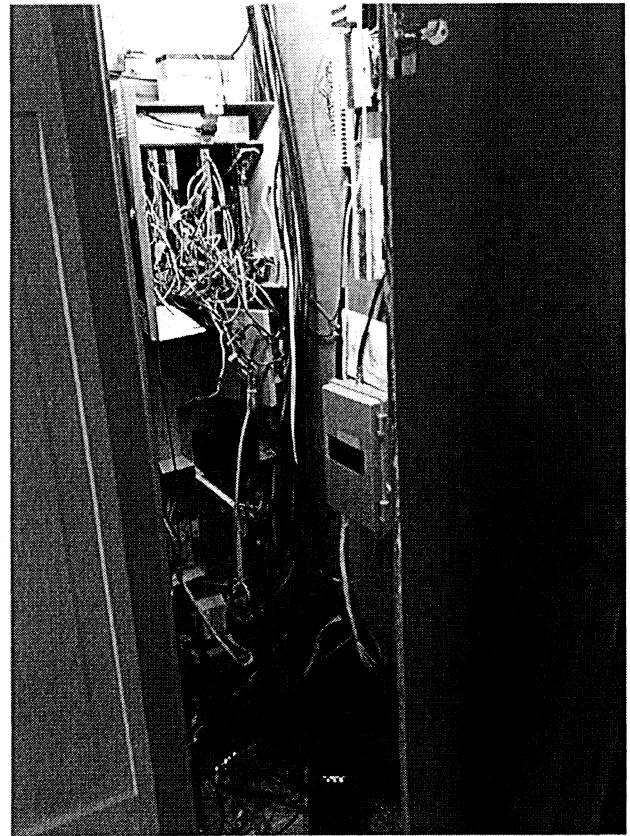
Arkansas Governor's Mansion Preservation Improvements  
Photograph #10

Left – Flooring and cracking occuring along baseboards

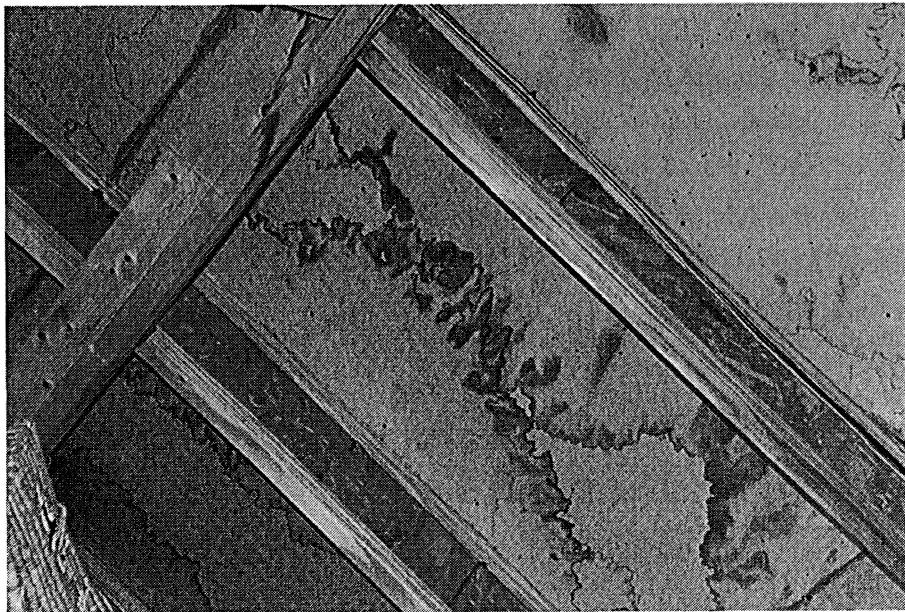
Water Stains in Attic of Carriage House
