### Re: Summary Fire Origin and Cause Report

File Name:	Greg and Melissa Harris
Address:	119 Davis Road, Atkins, Arkansas 72823
Client #:	HARRIS
Cause of Loss:	Fire
Date of Loss:	June 28, 2022 @ approximately 00:15 hours
J.S. Held Project #:	22062457

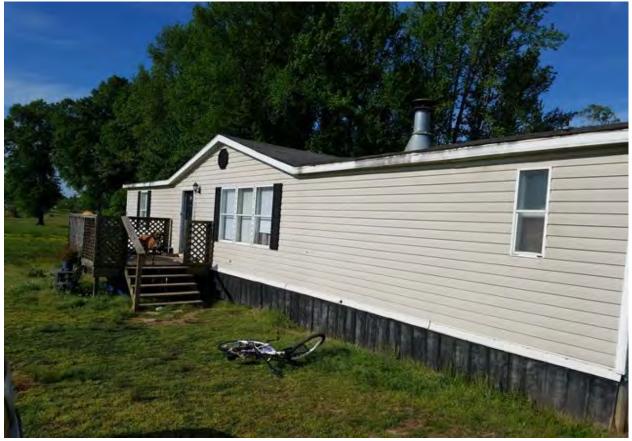
Pre-fire view of residence with 10' x 9' wood deck attached to the front, east side

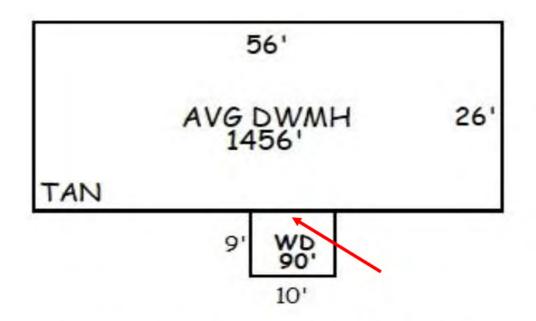
Fire pattern analysis, empirical data, data analysis, and witness statements revealed the fire originated outside the residence on the elevated wood deck attached to the front, east side of the structure. The fire spread upward and outward from that singular and localized area of fire origin. Due to the presence of an ignitable liquid that was dispersed into the area of fire origin, irregular fire patterns were observed that confirmed that the fire also burned downward through the wood deck and penetrated inward by entrainment toward the interior floor assembly around the front door entrance to the residence. The elevated and attached wood deck, the mid-section of the front, east side exterior wall assembly, and the roof assembly over the living room area were completely burned away because of the fire. An inverted and angular "V" shaped fire pattern was observed and documented on the interior side of the front door entrance at floor level. Heat stress and oxidation patterns were observed on the east side of the section of the steel I beam located near the front door entrance to the residence.

View of exterior dimensions with the area of fire origin denoted by a red arrow

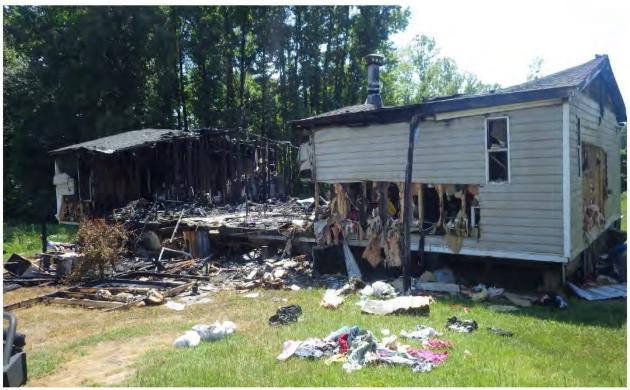
Photo No. 1: Front, east side elevation

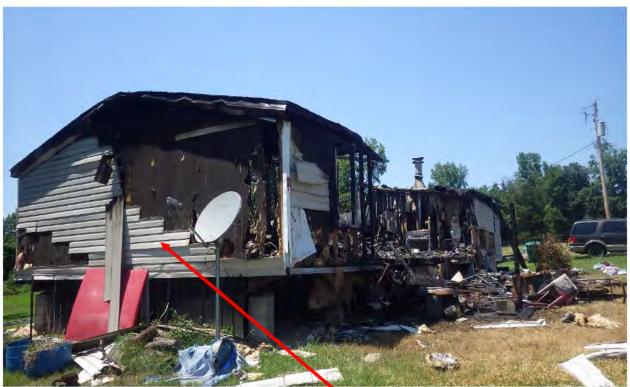
Photo No. 2: South side elevation

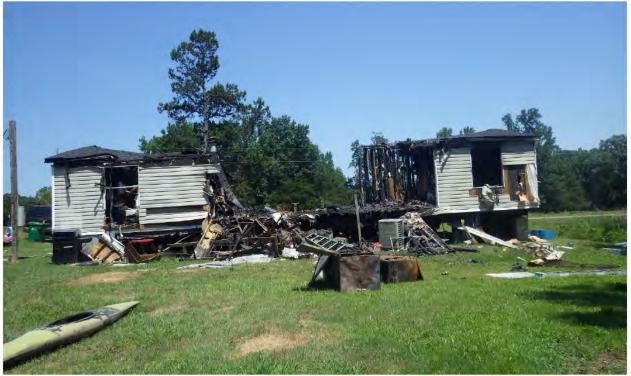
Photo No. 3: Rear, west side elevation

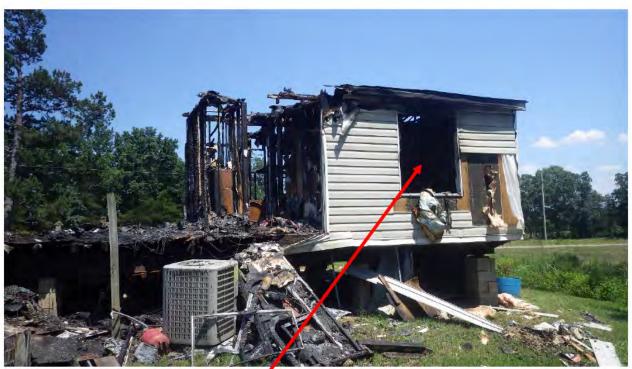
Photo No. 4: Elevated window at rear, west side used by Harris family to escape from fire

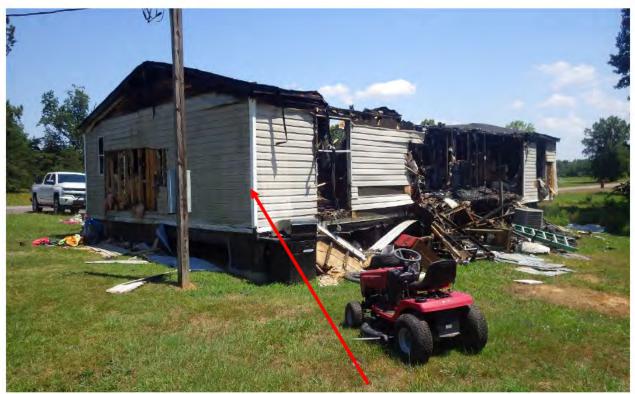
Photo No. 5: View of northwest exterior corner

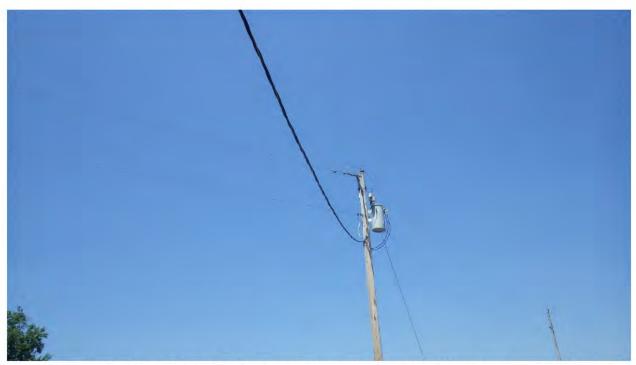
Photo No. 6: View of intact pole mounted transformer supplying power to residence

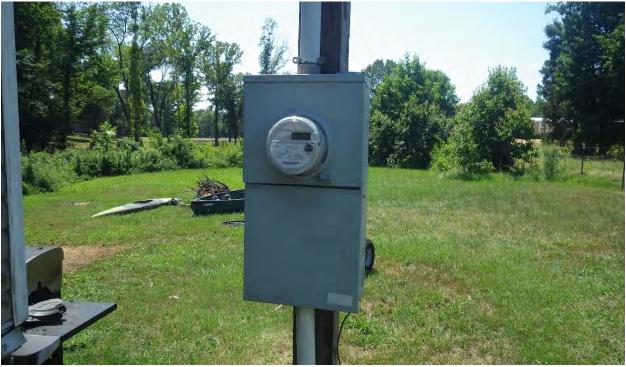
Entergy Corporation supplies electric service in the area. The electric service entered the structure from a pole-mounted electric meter socket located off the northwest corner of the structure. The electric meter was intact and still in place at the time of my inspection.

Photo No. 7: View of pole mounted electric meter socket and main breaker for residence

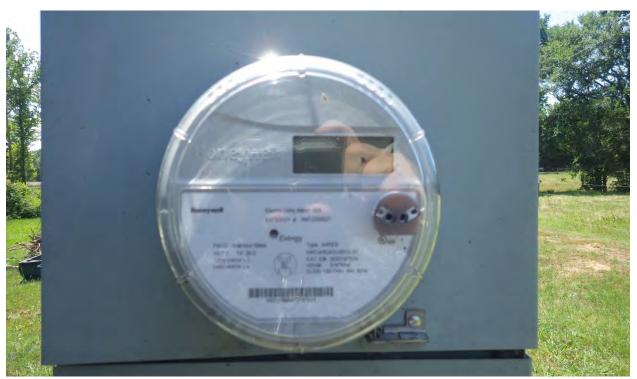
Photo No. 8: View of intact Entergy MDM (smart) meter manufactured by Honeywell

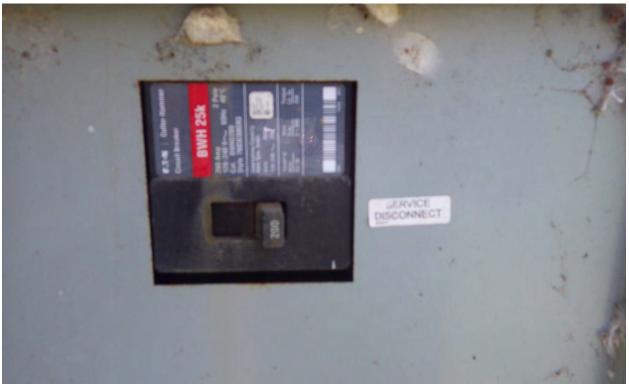
Photo No. 9: View of 200 amp Cutler-Hammer service disconnect breaker

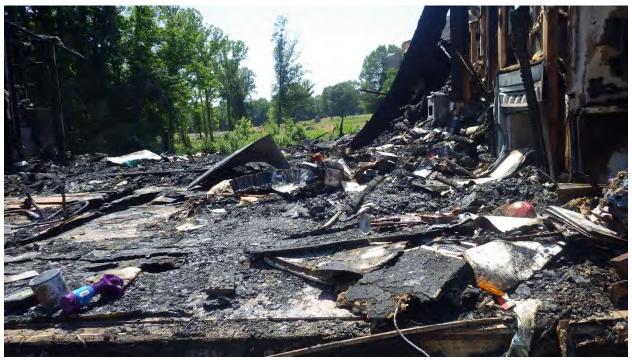
Photo No. 10: View of fire patterns at north side of living room

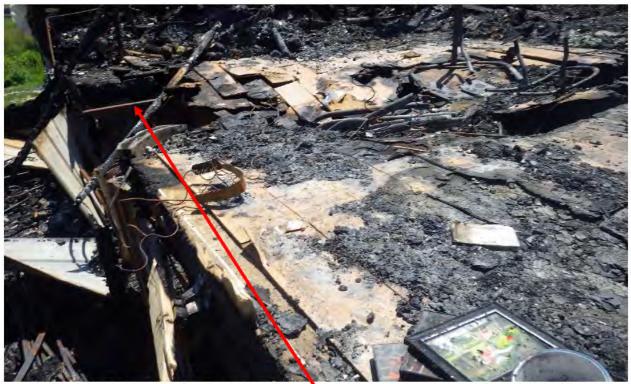
Photo No. 11: View of fire patterns at floor level near front door entrance to residence

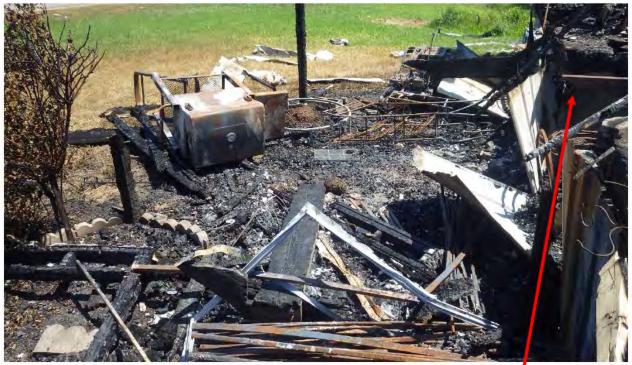
Photo No. 12: View of area where wood deck was located at front door entrance

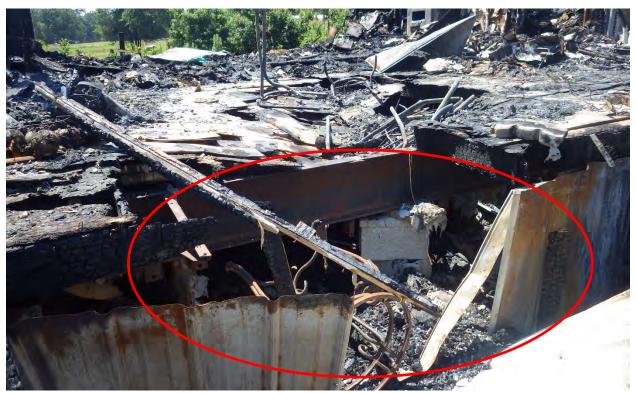
Photo No. 13: View of fire patterns at front door entrance where wood deck was attached to residence, note loss of mass and depth of char on wood framing

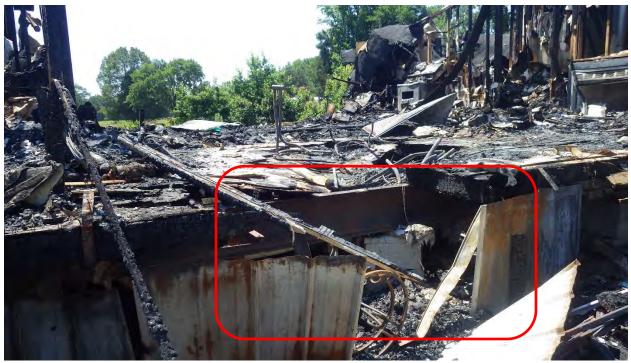
Photo No. 14: View of area of fire origin near exterior side of front door entrance

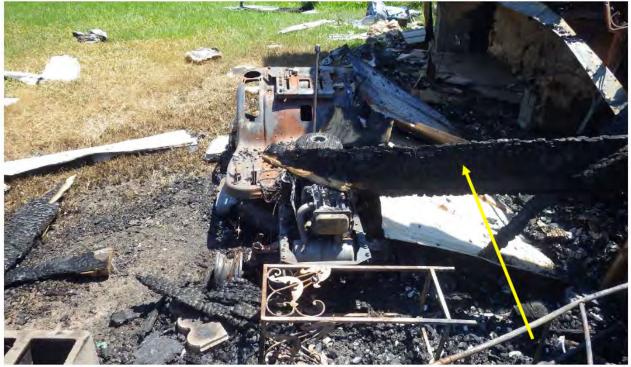
Photo No. 15: View of riding lawn mower parked at south end of wood deck, note fire patterns on inside of wood deck framing (shown with yellow arrow)

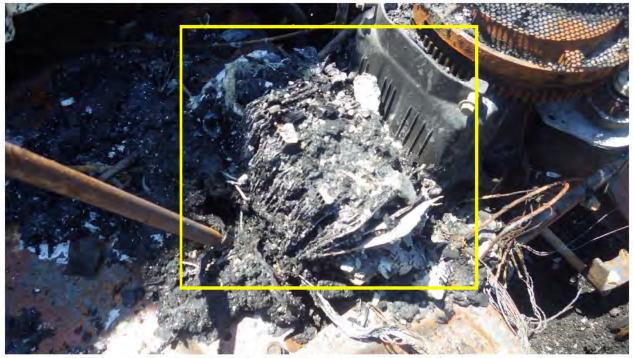
A detailed inspection of the area of fire origin confirmed that there were no electric branch circuits located in or routed through the area where the fire originated. Inspection of the battery and battery cables on the riding lawn mower located approximately ten feet to the south of the front door did not show any evidence of electrical activity to failure. A charcoal grill located on the east side of the wood deck was used by Greg Harris to cook steaks on the night of the fire loss but was not located in the area where the fire originated. Greg and Melissa Harris are both smokers and stated they did smoke on the front wood deck while they were grilling steaks several hours prior to the discovery of the fire. A fire caused by smoldering and unattended cigarette butts is not consistent with the timeline of events on the fire originated and the presence of an ignitable liquid in the debris sample taken from the area of fire origin. All potential and possible timelines, ignition sources, first fuel sources, and fire cause hypotheses were considered using inductive and deductive reasoning prior to reaching final opinions and conclusions regarding the cause of this fire.

Photo No. 16: View of remains of battery on riding mower

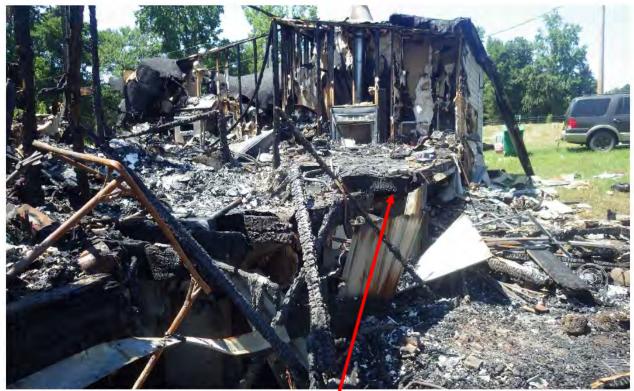
Photo No. 17: View of fire patterns at area of fire origin near front door, note that attached and elevated wood deck is completely burned away

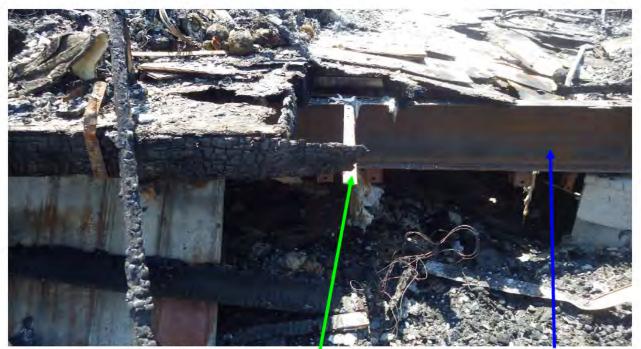
Photo No. 18: View of directional fire patterns at area of fire origin & tempering on steel

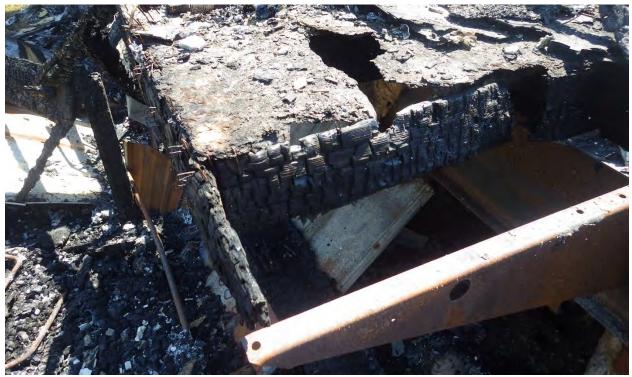
Photo No. 19: View of loss of mass, directional, tempering and depth of char fire patterns

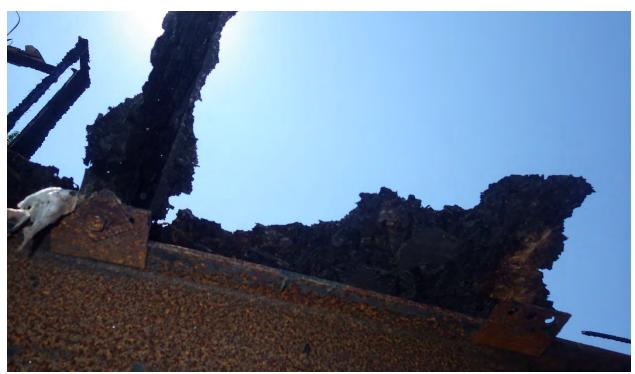
Photo No. 20: View of fire patterns on underside of sub-flooring near front door entrance

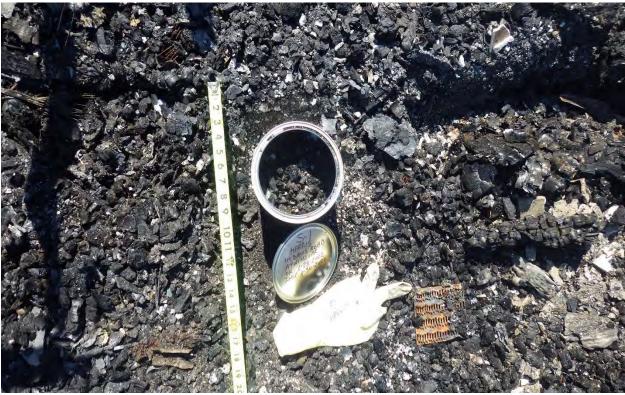
A light petroleum distillate was present in Item 1. Products in this range include, but are not limited to, some types of camping fuels, cigarette lighter fluids, and Naphtha. A copy of the lab report is enclosed. N.F.P.A. 921 – 2021 Edition Referenced Definitions:

Photo No. 21: View of debris sample S-1 collected from area of fire origin

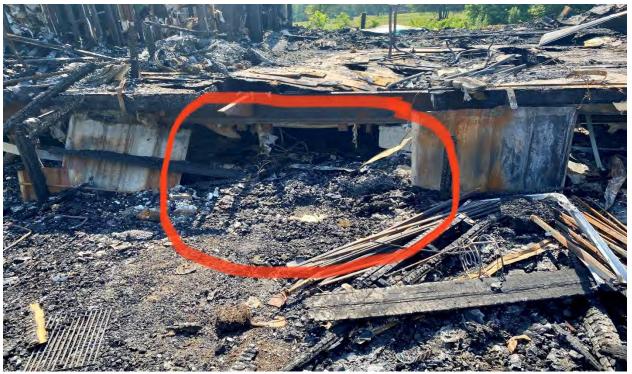
Photo No. 22: View of general area of fire origin on attached wood deck

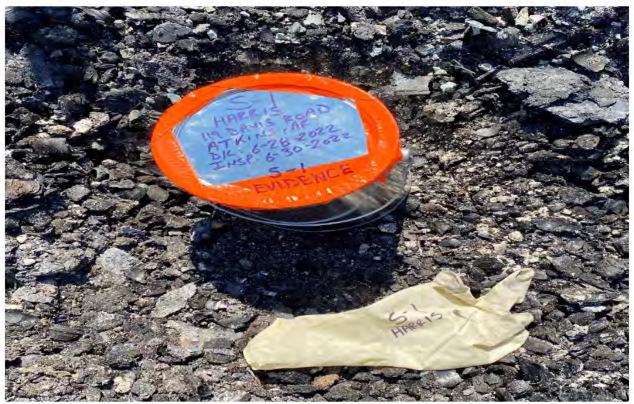
ltem No.	Brief Description	Location Recovered from	Date Collected
S-1	Debris sample taken from area of fire origin	Collected 22' 7" North of Southeast Exterior Corner and 1' East of East Exterior Wall Below Front Door	06/30/2022

Photo No. 23: View of sealed sample S-1 collected at ground level below front door entrance

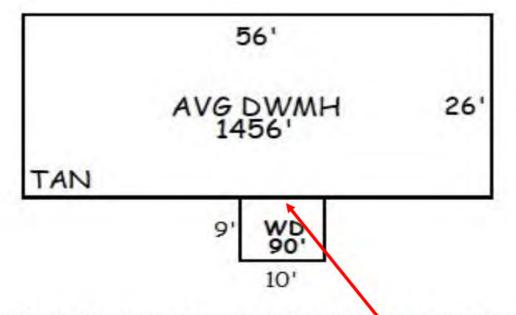
Photo No. 24: View of exterior dimensions with area of fire origin shown with red arrow
