Electrical Grid Security

Severe Storms

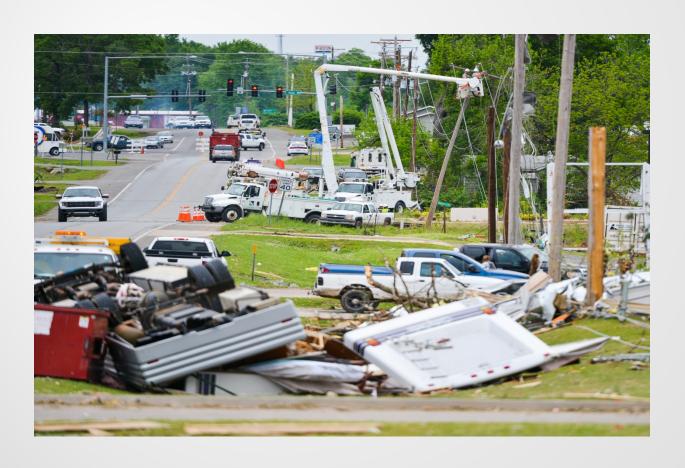
Distribution Line Repairs

- EF4 Tornado on April 27 began near Ferndale and traveled 41 miles to near El Paso
- Major damage occurred in the Mayflower Vilonia Areas
- On the distribution grid Entergy replaced 500 broken poles and re-strung 650 spans of electrical wire
- A force of 1,000 workers repaired most of this damage in a few days

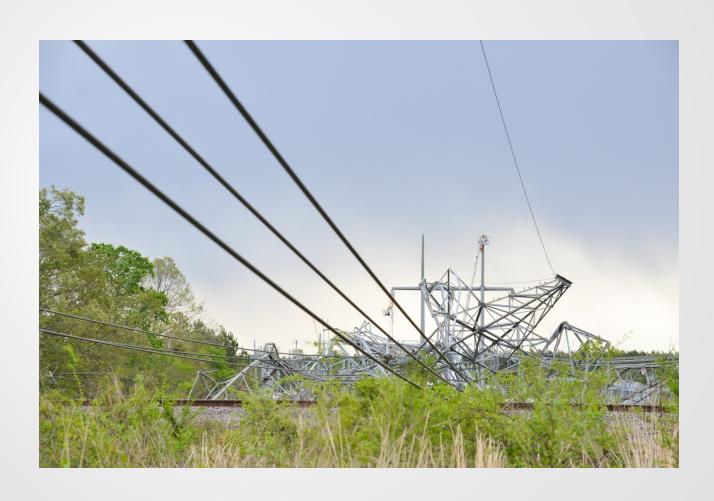
The tornado also destroyed 7 transmission line segments and the Mayflower substation

Transmission Tower Damage

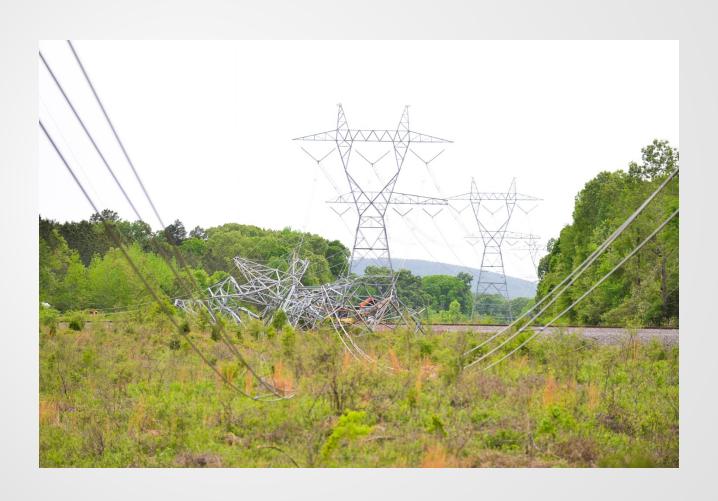
Transmission Tower Damage

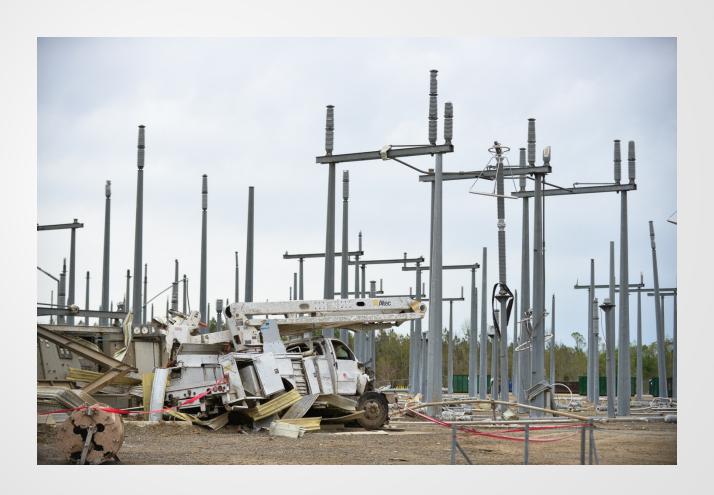
Mayflower Substation Damage

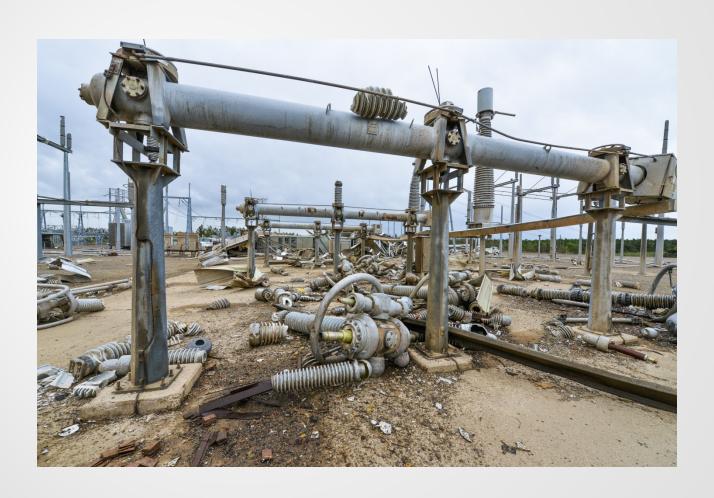
Mayflower Substation Damage

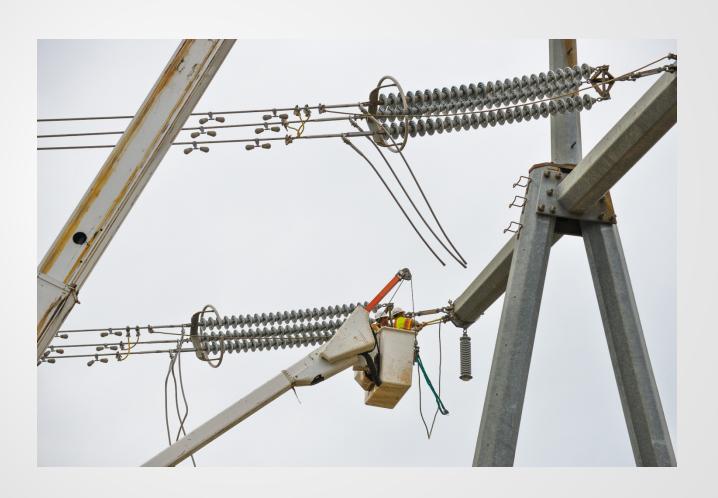
Substation Repair Work

- A team of 100 Entergy employees and 400 contractors worked
 7 days a week to rebuild the transmission lines and to erect a temporary substation.
- The damage severely limited the amount of electricity that could be delivered to the central Arkansas area from the west and north
- Arkansas Nuclear One (1800 MW) and the Independence Plant (1600 MW) were effectively cut-off
- The repairs were completed and the lines re-energized on June 11
- Had there been unusually hot weather in early June, there could have been afternoon brown-outs

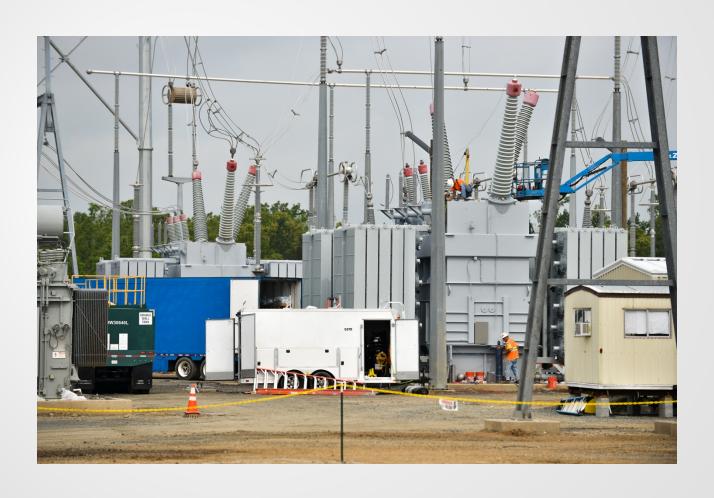
Substation Repair Work

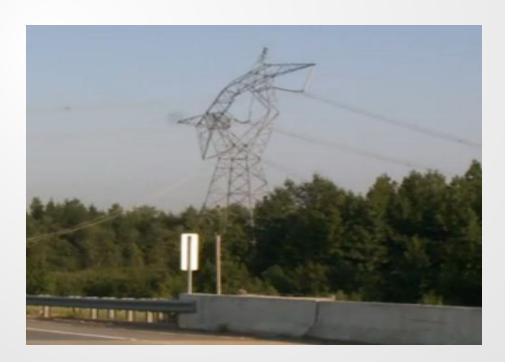
On August 21st, 2013 we had a power outage in Cabot.
 Tracking down the cause, we found a partially collapsed
 500,000 volt transmission tower with the line on the Union Pacific tracks.

- One hundred of the 125 bolts securing the tower to the foundation had been removed.
- A cable had been strung from the tower across to a tree on the other side of the tracks. It was snapped by the first passing train and the tower did not fall.
- In the early morning dark of August 21, someone climbed the tower 100 feet up in the air and with hacksaw sawed away the connectors, dropping a live line onto the tracks.
- A Union Pacific train struck the downed line and burst through it, causing immediate outages and \$100,000 in damage.
- The FBI took over the investigation as a possible terrorist attack.

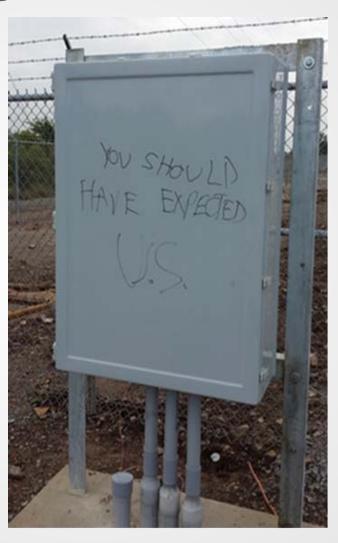
- On September 29 someone entered a 500,000 volt substation near Scott by cutting the fence with bolt cutters.
- Locks on the electronic control room at the substation were also cut. The interior of the control room was splashed with gasoline and the room set on fire.
- The control room was consumed by fire and the damage exceeded \$2,000,000.
- A message left on a metal panel sent the FBI and Homeland Security into full terrorist response mode.

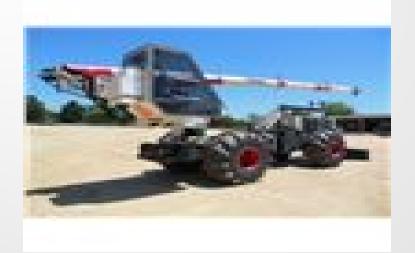
- The suspected terrorist struck again a week later. Two power poles belonging to First Electric Cooperative were the target.
 One was cut through with a chain saw and the other an axe.
- The suspects then hot-wired a Kershaw SkyTrim tractor and used it to finish the job, causing an outage for 10,000 First Electric Customers.
