# The Arkansas Discovery Farm Program

- On-farm research and demonstration
- Address local and regional water issues
- Sound science, unbiased, stakeholder led
- Farmer empowerment, promote conservation
- Document practice effectiveness

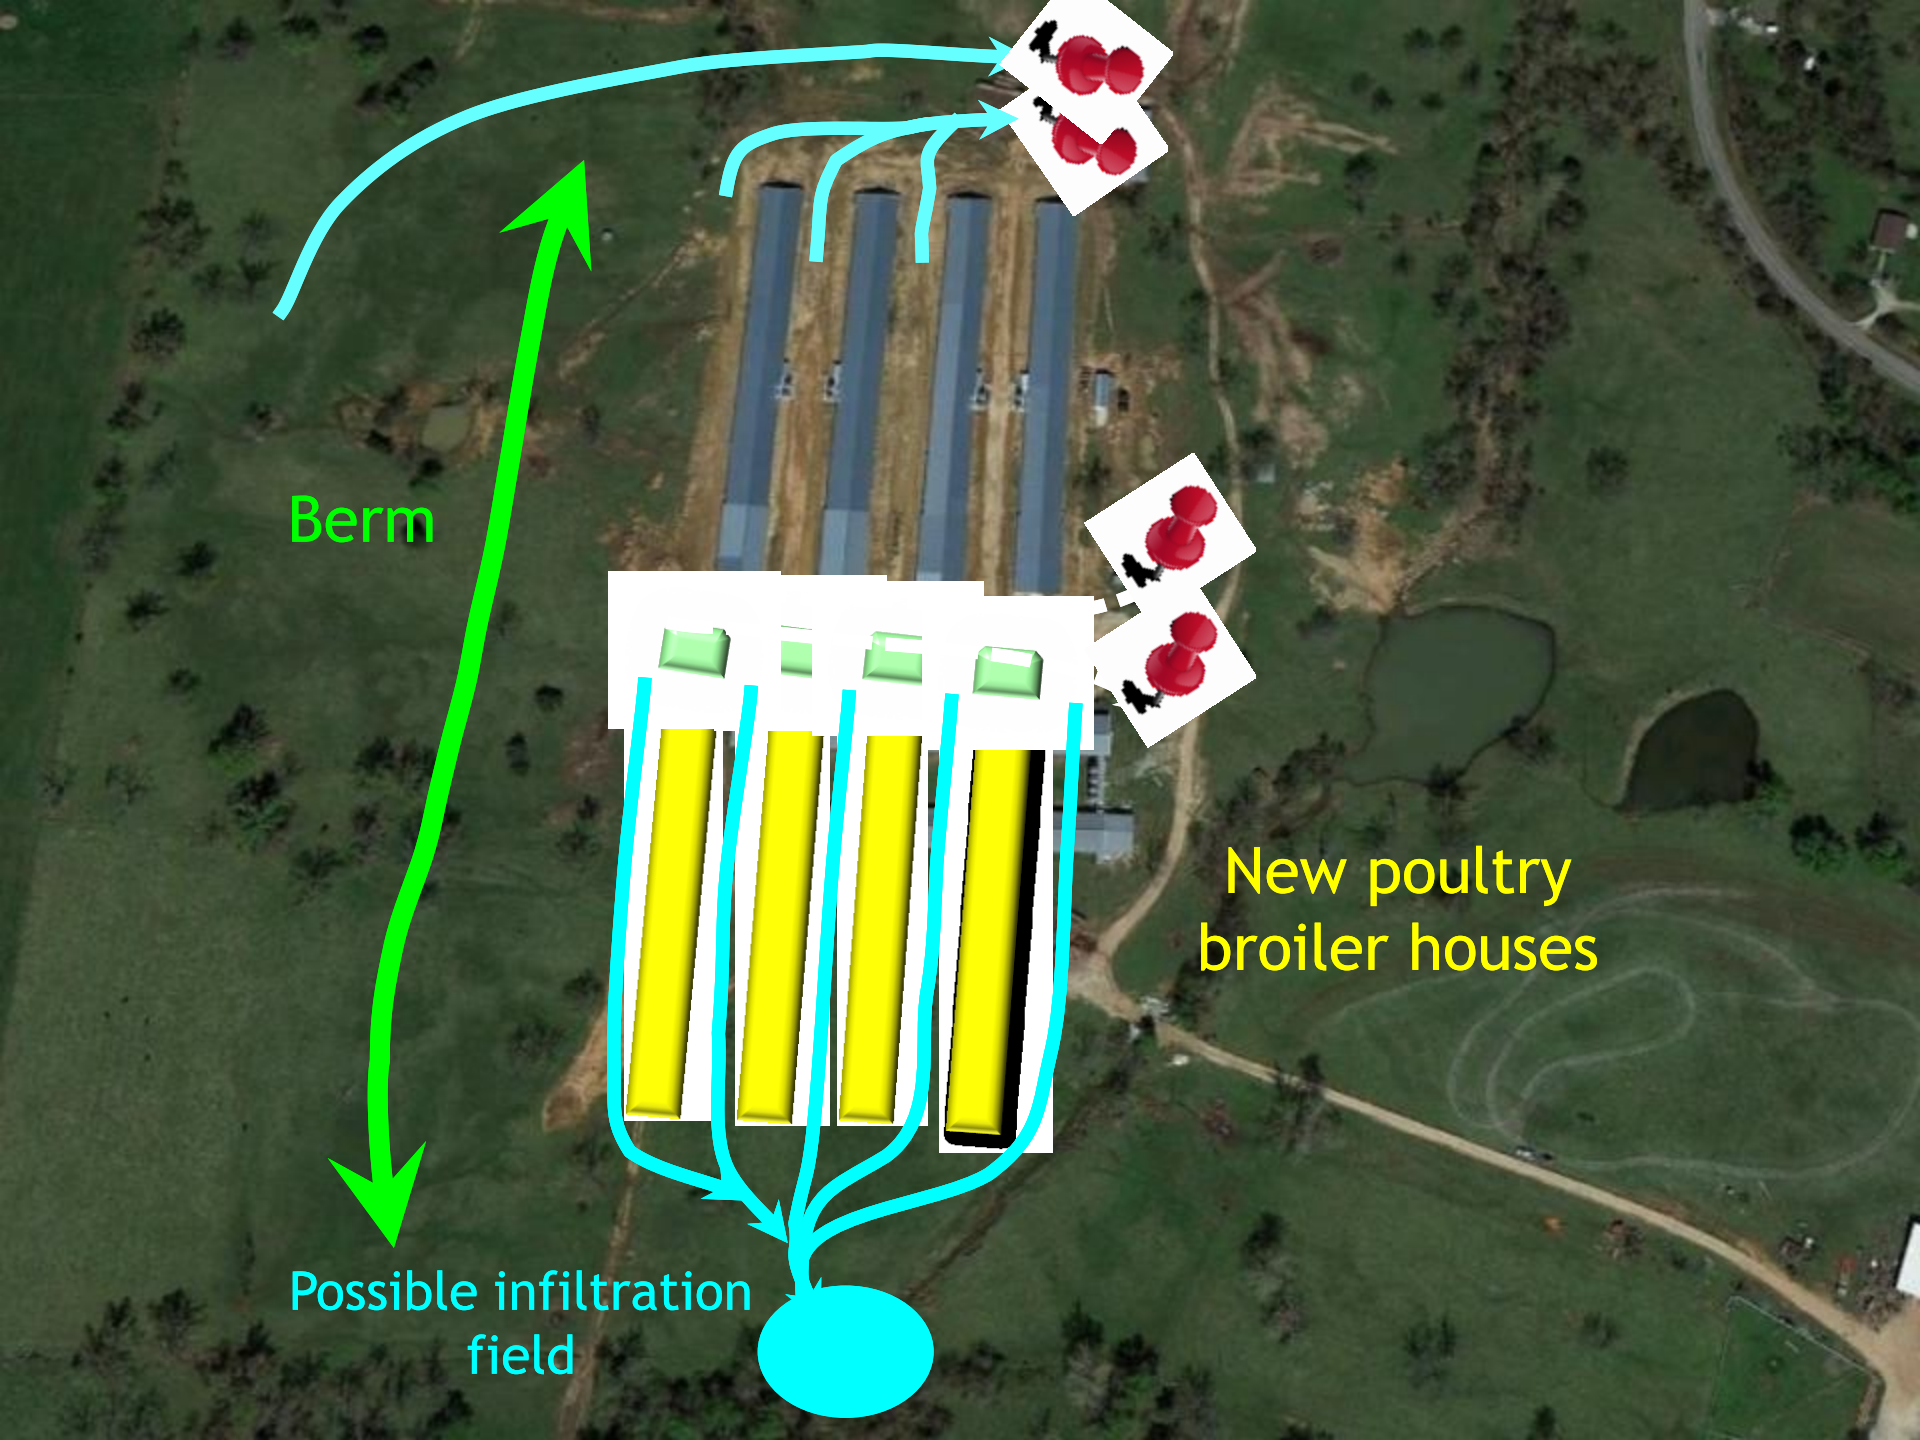
Berm

New poultry  
broiler houses

Possible infiltration  
field

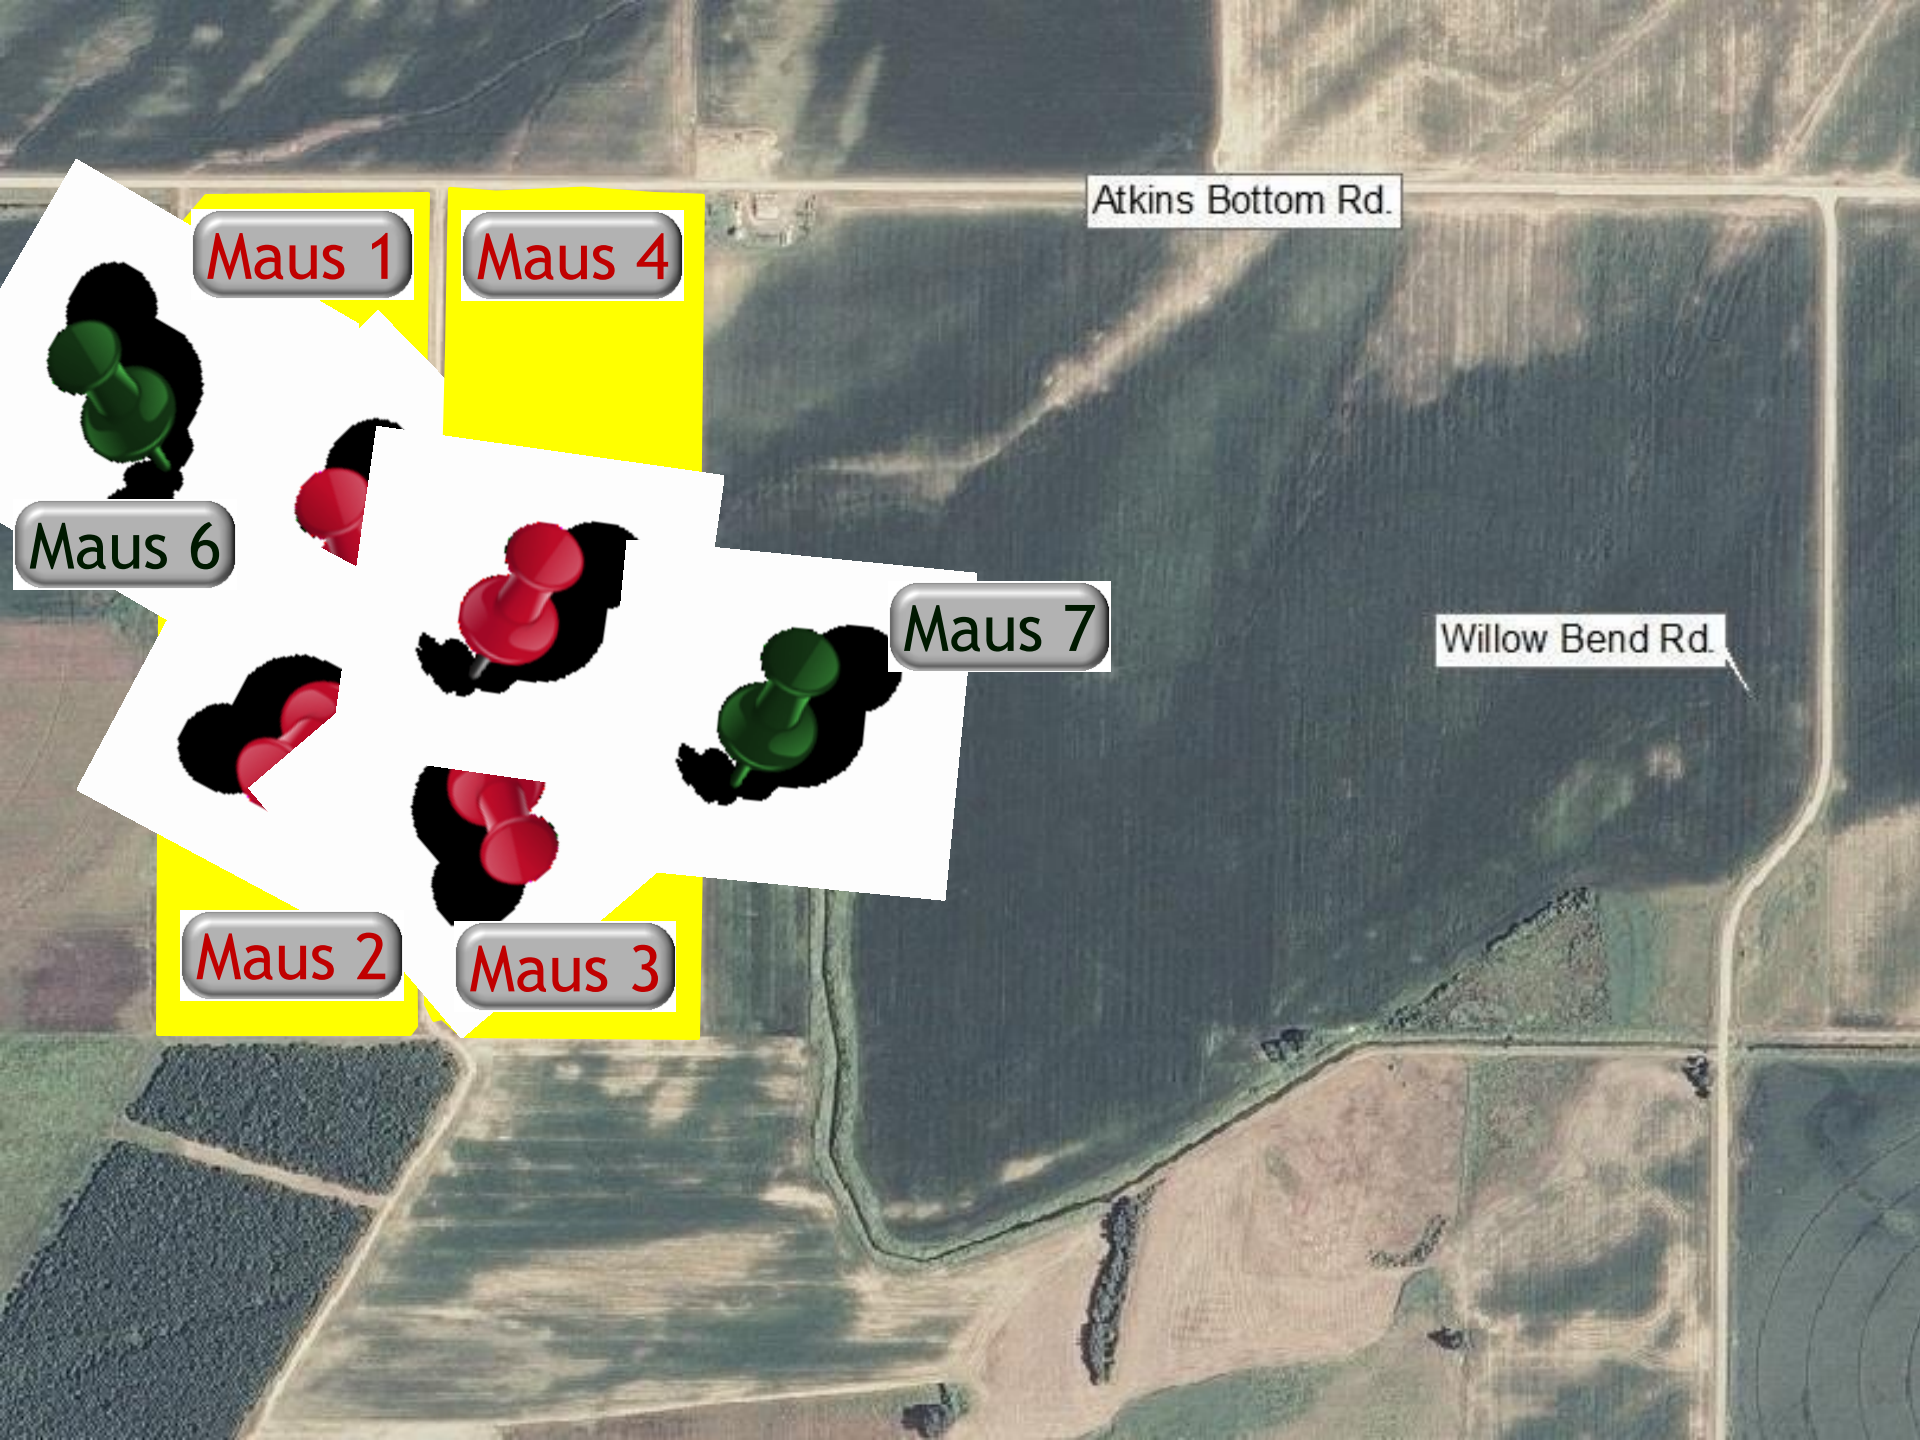
Maus 1

Drainage return  
for 1200 acres

Tail-water recovery

- Corn (200 ac), wheat (200 ac), rice (240 ac), and soybean (400 ac), woodland (55 ac)
- Evaluate effect of cover crops on nutrient & sediment runoff

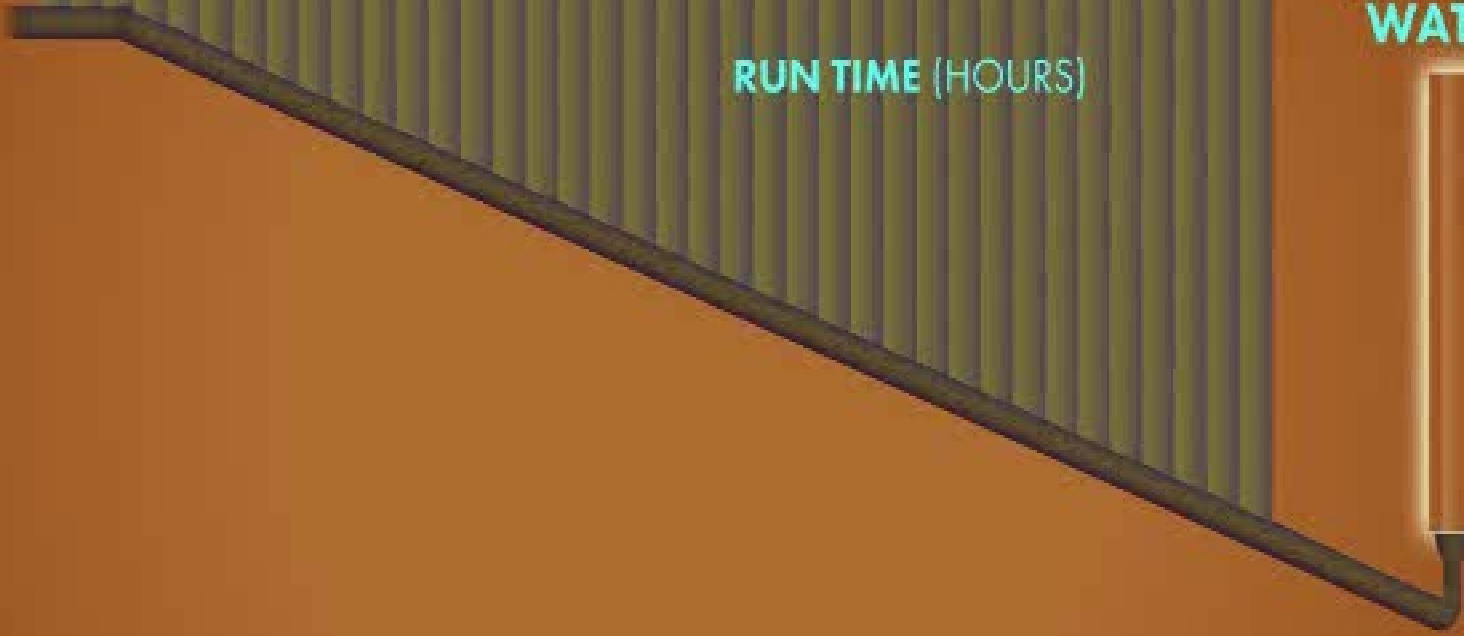
POLYTUBING

RUNOFF  
WATER

RUN TIME (HOURS)

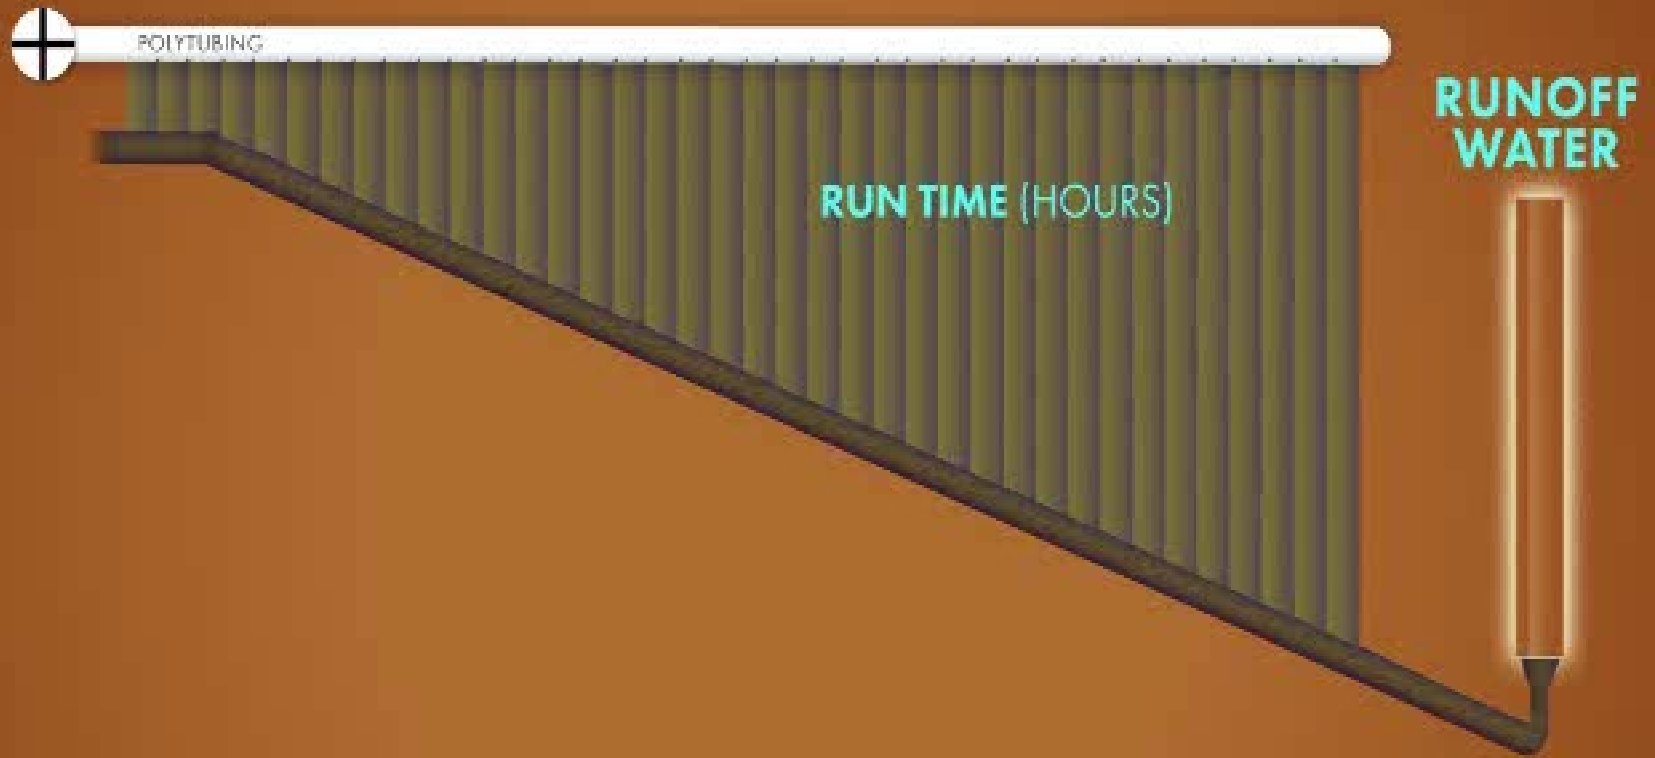
# Using PHACET

PHAUCET - Pipe Hole and Universal Crown Evaluation Tool
