## Arkansas Governor's Mansion Commission

SUBJ: Annual Mansion Report

DATE: November 1, 2016

### TRANSMITTAL AND CONDITION DEFINITIONS

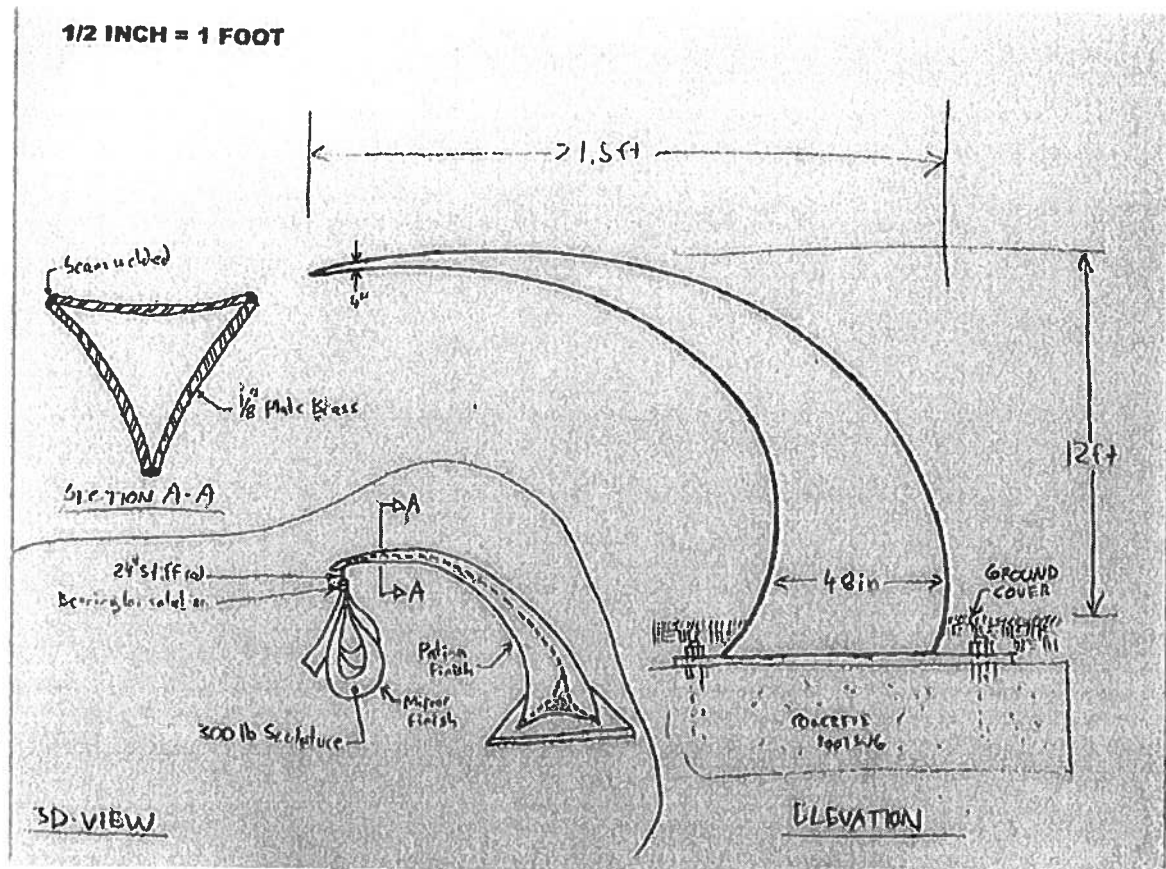
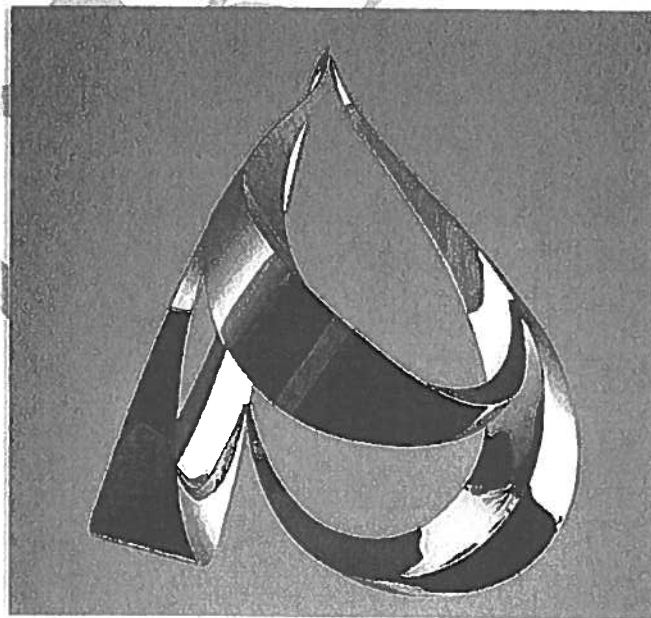
Photograph #3  
Sketch of "Rain of Faith"  
Sculpture & Support

" Rain of Faith " sculpture in Mansion East Garden  
Install base and arc support to suspend sculpture

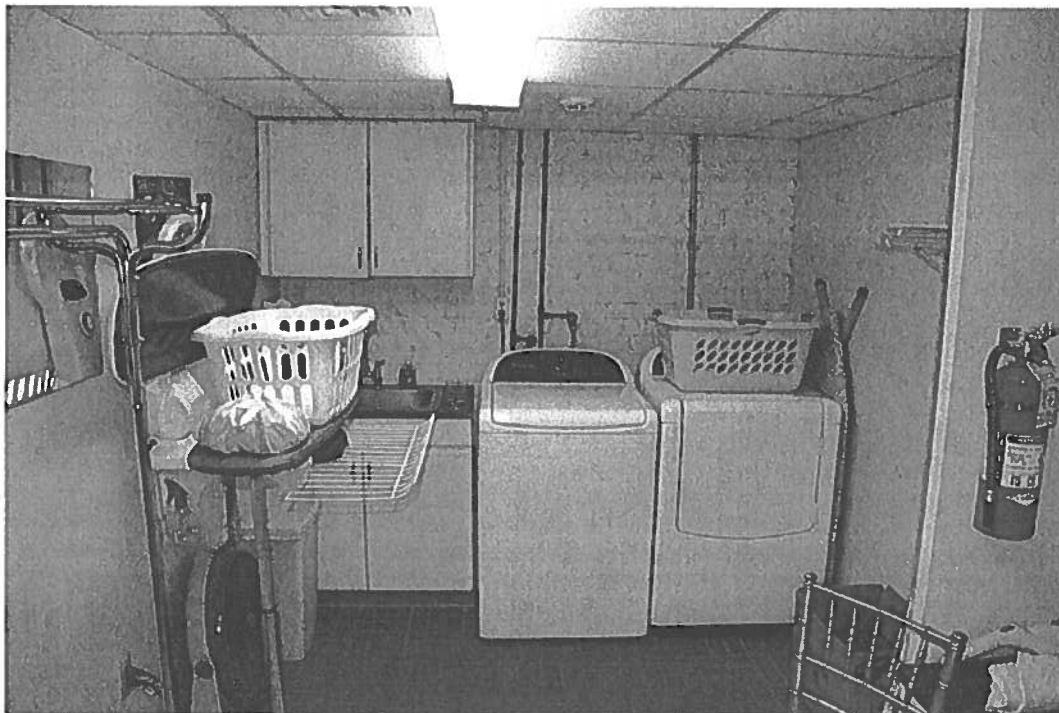
Arkansas Governor's Mansion Preservation Improvements  
Photograph #6

the basement, requiring the family members to sneak upstairs, even during public events, to reach a powder room! Simply modifying an existing janitorial closet will create a private powder room for the family in the basement. See *Mansion Basement Footprint-Exhibit "B", Page 33 and Photograph #6, Page 25.*

Current Laundry Room shared by the Mansion Staff and the First Family

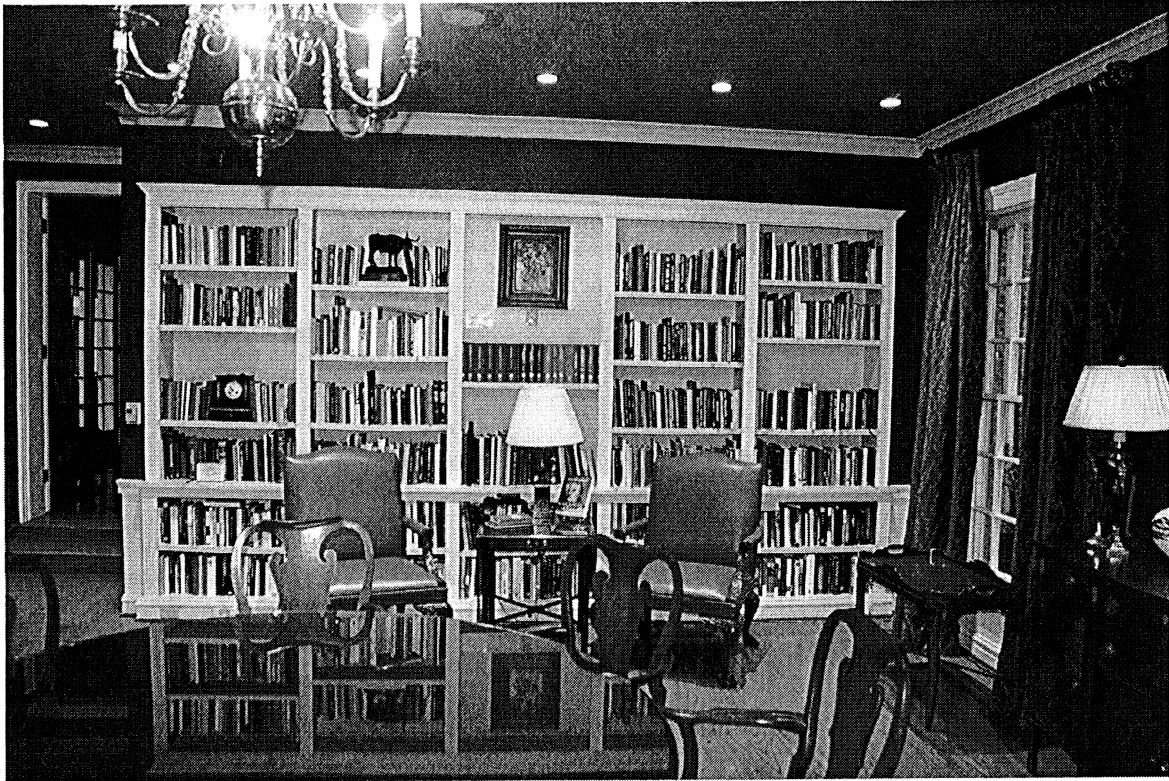
Arkansas Governor's Mansion Preservation Improvements  
Photograph #8

**3) Mansion Library:** through research of the Mansion's original construction and early improvements, it has been found that the Library, often used by the Governor and Mansion administration for meetings, has been modified over the years and has lost or covered up several of its most unique architectural elements. This application will allow for the restoration of the Library's original fireplace, reconstruction of its mantle, hearth and bookshelves, and return the Library very close to its original design. This will also include repairing and refinishing the beautiful hardwood floors, millwork repairs to the window panels, and patch and paint for the plaster walls. See *Mansion First Floor for location – Exhibit "C", Page 34 and Photograph #7, Page 26.*

Governor's Mansion Library  
Proposed restoration of original design - fireplace, hearth & mantel  
with bookcases flanking each side

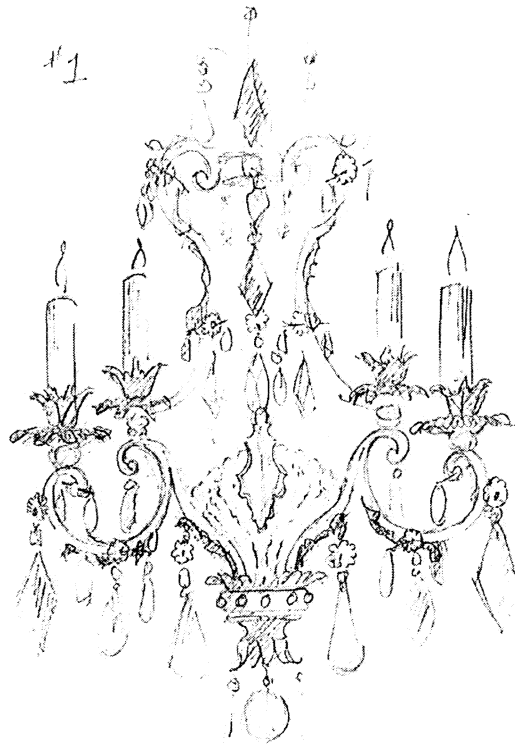
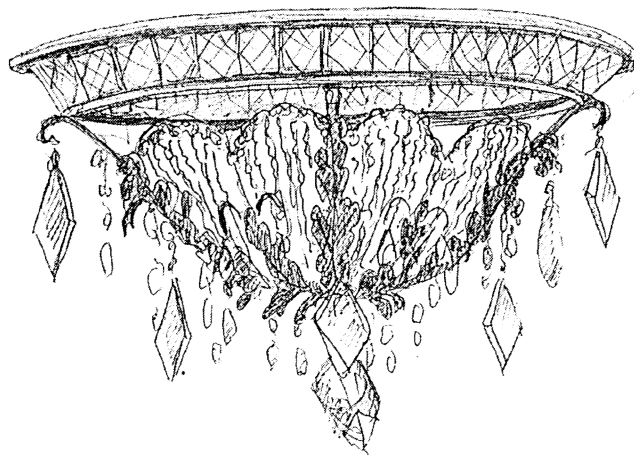
Arkansas Governor's Mansion Preservation Improvements  
Photograph #11

Lastly, the application includes the addition of eight wall sconces and four crystal chandeliers in the Grand Hall vestibule and entryway which has become more and more the primary entrance for event guests when it is not necessary for organizations or party venues to utilize the Mansion for their function, thus further reducing the wear and tear and maintenance on the original Mansion. The current entry hall located at the west entrance has limited lighting and no decorative illumination. Custom fixtures are being proposed for the entry vestibule and the transition from the entry into the magnificent Grand Hall, with the commissioning of the pieces by Thomas Grant of Grant Chandeliers, Dallas, Tx, Mr. Grant was commissioned in 2009 for the beautiful custom-designed chandelier centerpieces hanging in the Grand Hall. The eight wall sconces and four ceiling-mounted fixtures will echo the design of the Grand Hall chandeliers, once again incorporating numerous traditional symbols of our State on a much smaller scale with the purpose of continuing a complementing lighting design throughout the grand facility. As the First Lady remarked, "guests will certainly know they have arrived at the Grand Hall" when they see these exquisite fixtures. *See Photographs #11, Page 30.*

Thomas Grant Chandeliers

Wall Sconce Design for the Grand Hall West Entry Vestibule

Ceiling Mounted Chandelier Design for Entryway leading to Grand Hall

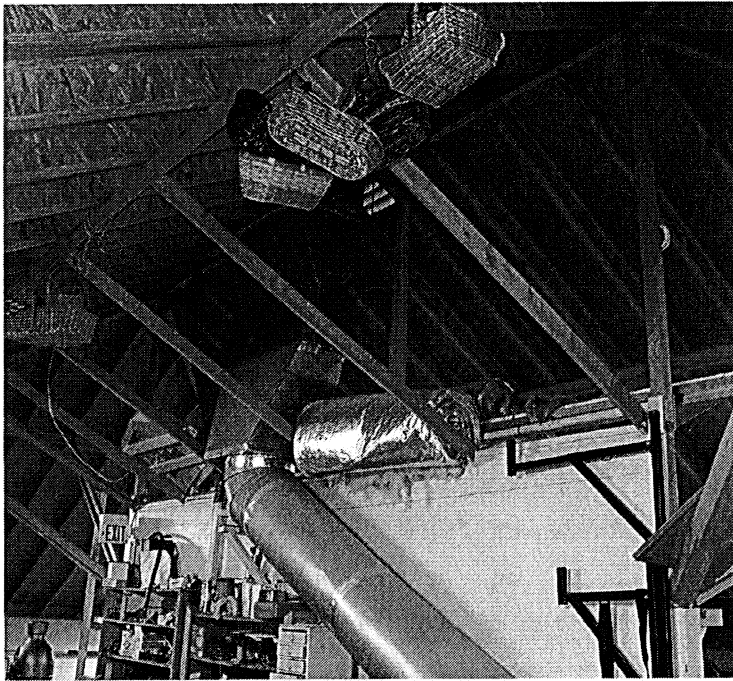
Arkansas Governor's Mansion Preservation Improvements  
Photograph #12

**7) Carriage House:** the final element included in the application is improvements desired for more effective use of the Carriage House. The Carriage House is the work hub for the Mansion, Grand Hall and grounds/garden maintenance. It houses the maintenance office; all the tools and equipment utilized for the grounds and facility maintenance, and provides much needed storage for the entire facility. It was found during the inspection conducted by the licensed inspector that the joist hangers used for the Carriage House attic and roof structure were improperly installed and also lacked rafter ties creating a structural concern. After further inspection by a structural engineer, it was determined that structural strengthening is recommended to preserve the integrity of the roof structure. The good news is that once this structural repair is made, the attic space can be enclosed and used for expanded and much needed conditioned storage. The expansion of the HVAC in the Carriage House will also help to correct a long-running humidity and ventilation issue as a result of the building being constantly filled with ambient air due to the open nature of the Carriage House. The proposal will also add roof snow/ice guards for safety and a mechanical lift to assist with moving large items to the attic storage rather than by way of the single open staircase that has been deemed a safety risk. *See Site Plan – Exhibit "A", Page 32 for location and Photograph #12, Page 31.*

Interior – Attic of Carriage House
